ENGINEERING—GEOLOGICAL IMPORTANCE AND POSSIBLE ORIGIN OF THE STRESS RELIEF OF THE ROCKS OF THE CORDILLERA BLANCA, PERU

MENCL V., Professor, Research Engr., IGHP, Žilina, Czechoslovakia

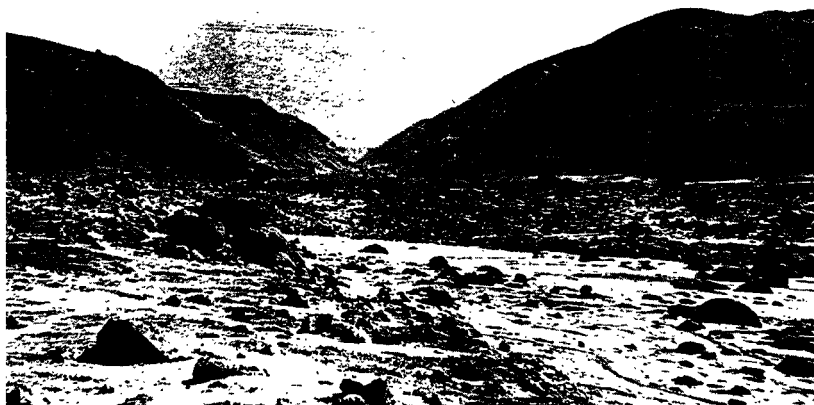
Fig. 2 - The site of the destroyed village of Randra-hirca at the mouth of the Shacsha valley into the Santa valley. Nevados Huascarán is in the background.

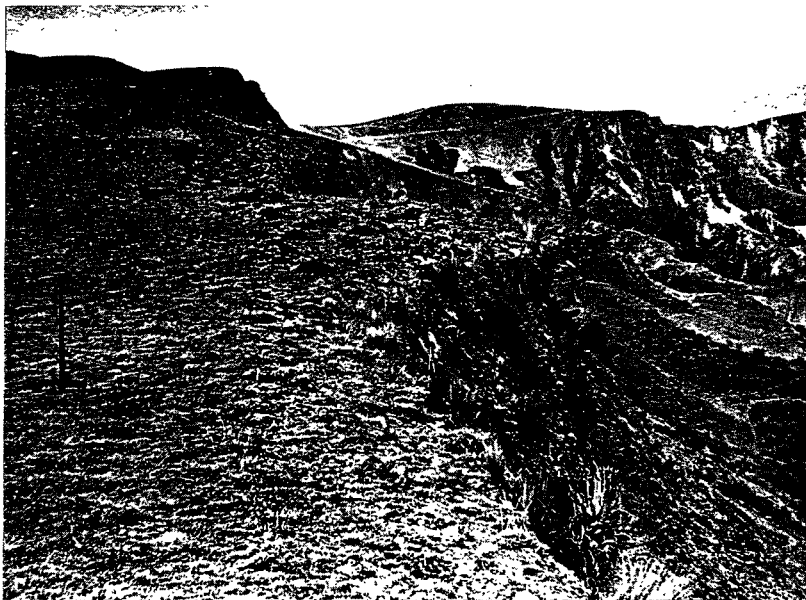
It is the author's opinion that the collapses of rocks cannot be attributed to the earthquake shocks only and that a considerable fracturing of rocks due to stress relief is a contributing factor. The relatively good stability of the strikingly high walls of the canyons cut into the thick mass of fluvioglacial deposits (Fig. 6) of the earthquake area can be given as an indirect proof. The material of terraces also proved to be stable although they are often deposited on steep rock slopes.

Fig. 6 - View of a small part of a large complex of canyons cut into the fluvioglacial deposits more than three hundred metres thick. The photograph shows the only place where the borders of the canyons suffered by earthquake (cracks on the left). South of Huaraz, Peru.

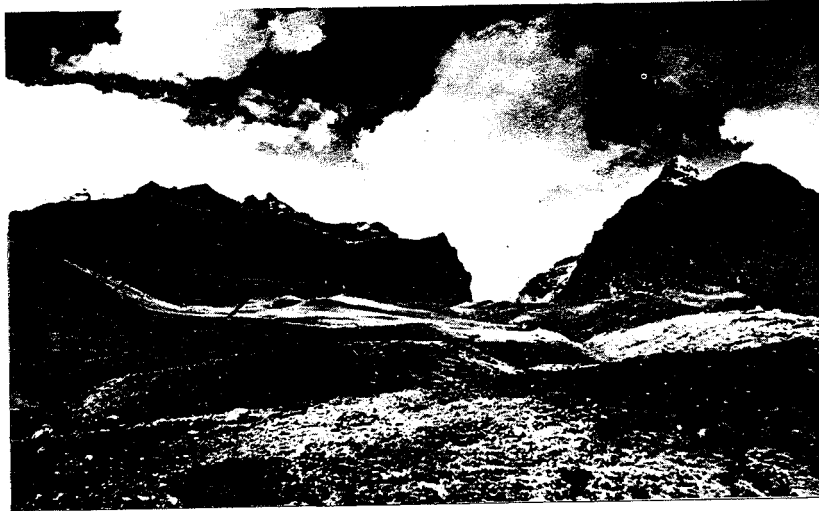
Fig. 8 - Recent eastern fault line manifested by a dark scarp wall which runs many tens of kilometres along the mountains and is accompanied by a set of fan scarps.

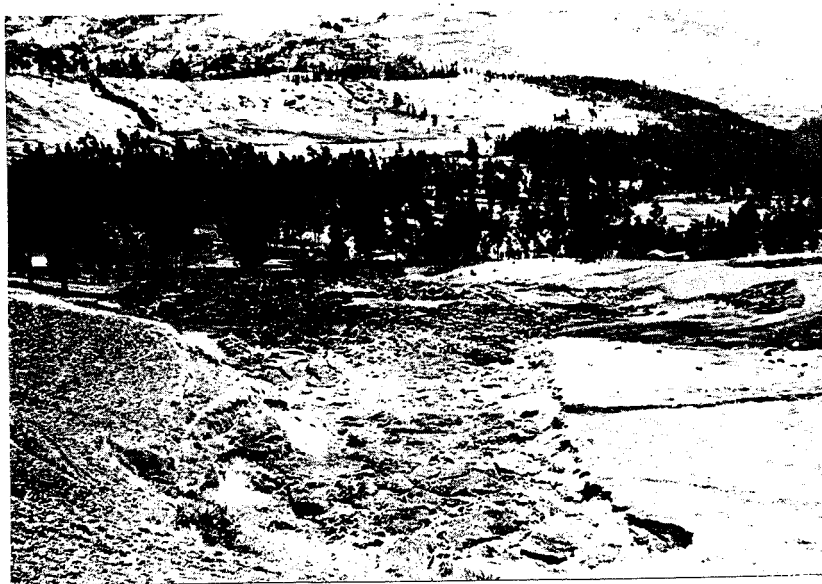
Fig. 9 - An example of many landslides developing in the outwash material. Photograph is taken from the front of the flattened terminal moraine. The overgrown area coincides with the western recent fault. The hill behind is of volcanic material belonging to the Cordillera Negra.

The lack of stability of the slopes along the two recent partial faults may therefore be attributed not only to the rather steep inclination of the terrain and to the presence of water, especially in the western fault but also to the softening of the soils owing to the extension occurring normal to the fault direction (Figs.9, 10). The presence of hot springs speaks for the tensional pull across the fault zone, too.

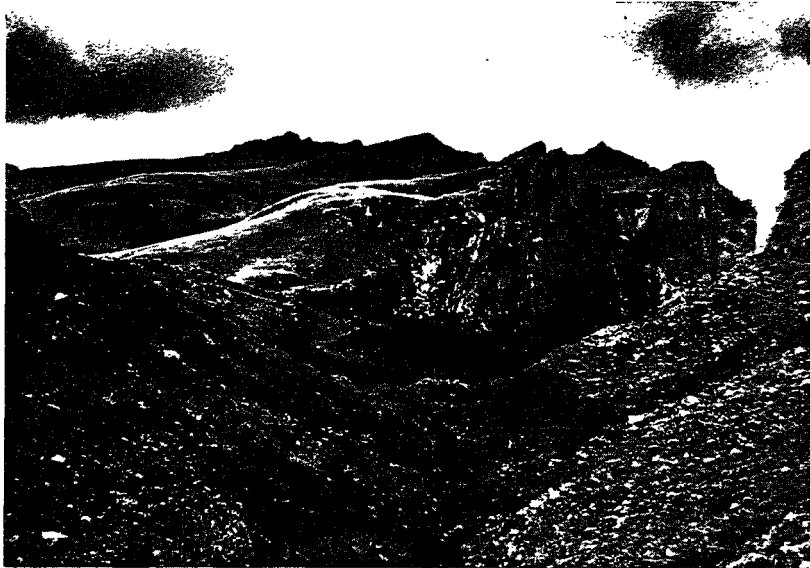
Fig. 10 - The eastern recent fault cutting the lateral moraines at the mouth of the valley de Paria near Huaraz. The width of the sunken belt bordered by the outward and bakward scarps is about 40 metres.

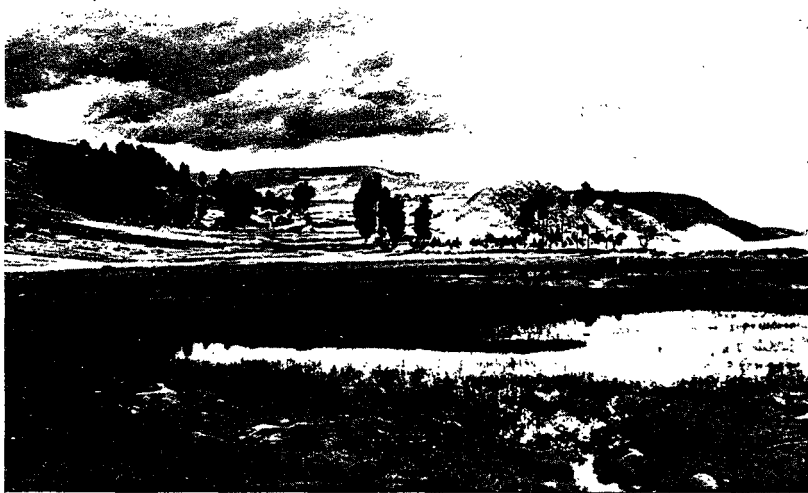
Fig. 11 - The "graben" of the fault zone situated opposite to Recuay, 140 m high above the right bank of the Santa river. The plain has been irrigated which contributed to the poor stability of the slope above the river which lies to the right of the photograph.

Very impressive are the two areas where the fault zone enters the Santa valley. The upstream of Huaraz has been characterized by the old large landslide at Recuay. The "graben" of the fault zone lies 140 m above the right bank of the Santa river (Fig.11). The bank itself is formed of pyroclastic rocks. During the 1970 earth-

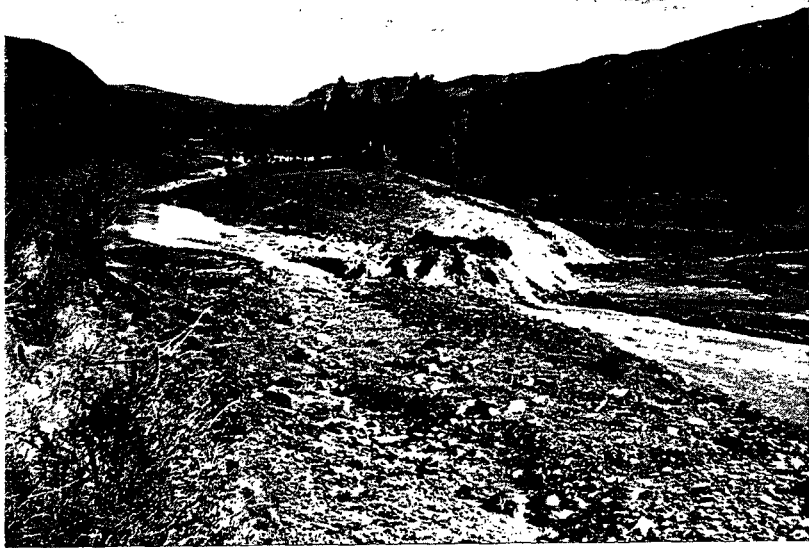
quake the slope above the right bank of the river collapsed. The head scarp of the recent slide reached 100m above the river. The slide extends across the river and the river floor was heaved upward thus forming a small hill (Fig. 12) and blocking the river.

Fig. 12 - The toe of the landslide at Recuay. The heaved toe consisting of pyroclastic rock blocked the river.

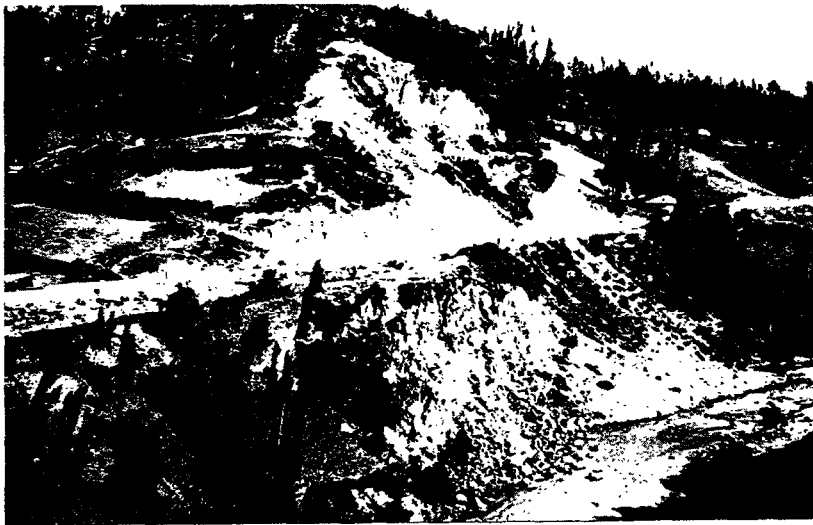
A rather similar situation developed at Palmira, downstream of Huaraz. The toe of a large landslide situated on the fault zone is formed here by an andesite block belonging to the volcanic rocks of the Cordillera Negra. As seen from Fig. 13, the resistance of the block has been reduced by river erosion. The movement of the slope was promoted by intensive irrigation using the rear scarps of the landslide as water channels.

Fig. 13 - The river leaving the volcanic rocks before entering the Cretaceous complex near Palmira. The andesite block formed the abutment of a large landslide of the glaciofluvial material filling the fault zone, which is situated behind the block. Due to gradual river erosion, the block moves slowly into the river. The roadway collapsed and was reconstructed at least two times.
