# Hazard mitigation of glacial lake outburst floods in the Cordillera Blanca (Peru): the effectiveness of remedial works

A. Emmer<sup>1,2</sup>, V. Vilímek<sup>1</sup> and M.L. Zapata<sup>3</sup>

Cordillera Blanca; glacial lakes; GLOFs; hazard mitigation; natural dams; remedial works.

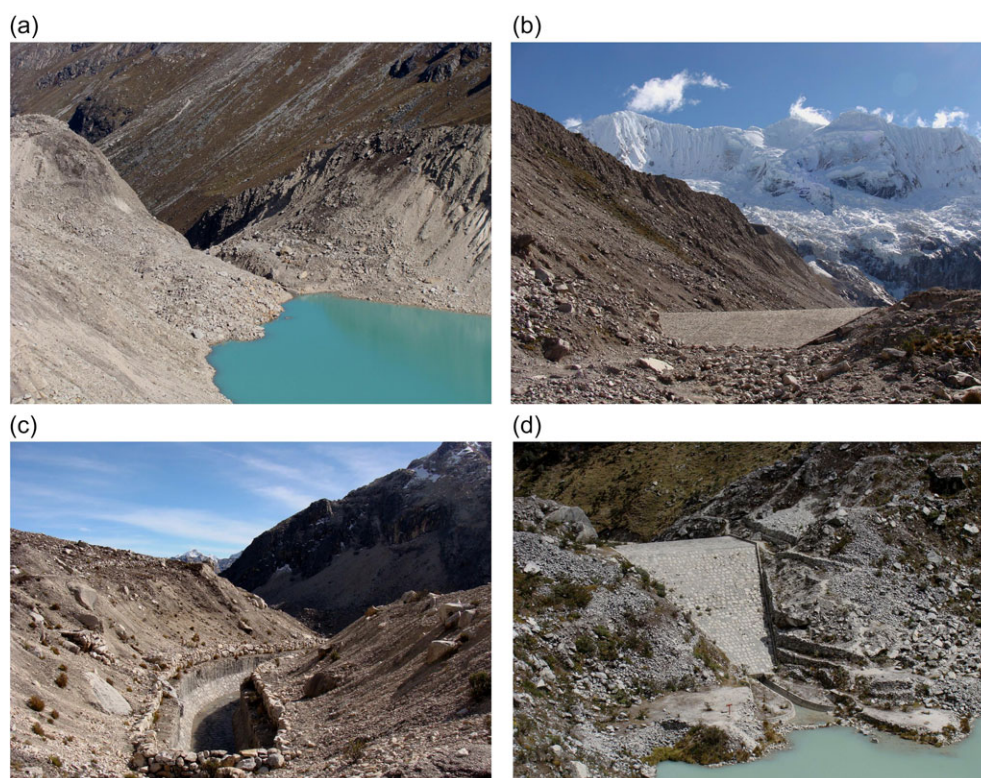
*Open cuts* are implemented by cutting through the moraine dam to lower and/or fix the lake level (and thereby the volume of retained water). Another goal is to prevent a surface outlet due to erosion following a sudden increase in flow rate (e.g. after an icefall into the lake) by cementation and concreting. Open cuts are mostly combined with artificial dams in the Cordillera Blanca (see below), but there are cases where they are implemented independently (e.g. Lake Arhueycocha in the right tributary of the Santa Cruz Valley, Lake Cochca above Lake No. 513 in the Hualcán Valley, or Lake Milluacocha in the Ishinca Valley; see Figure 2(a)).

*Artificial dams* (Figure 2(b)) are built especially to increase dam freeboard (and thereby the retention potential of the lake) and to prevent a lake outlet due to the direct impact of a displacement wave(s) and unexpected increase(s) in water levels. Artificial dams are usually built from concrete or stone walls with earthen fill, and they are often more than 10 m high. They are implemented solely in moraine-dammed lakes in the Cordillera Blanca and mostly in combination with open cuts (see above), above the lake outlet or in other locations where the dam freeboard needs to be increased (usually a naturally lowered point on the moraine crest; see Figure 2(c), (d)).

**Figure 2** Example of open cuts and artificial dams. (a) A failed moraine dam of Lake Milluacocha equipped in 2000 with an open cut; (b) a separate artificial dam increasing the dam freeboard of Lake Palcacocha in the naturally lowered part of the dam crest (not the lake outflow); (c) a downstream view of the open cut of Lake Ishinca from an artificial dam providing a freeboard of 5 m; and part (d) an artificial dam providing a freeboard of 12 m and an inlet to the open cut draining Lake Llaca.

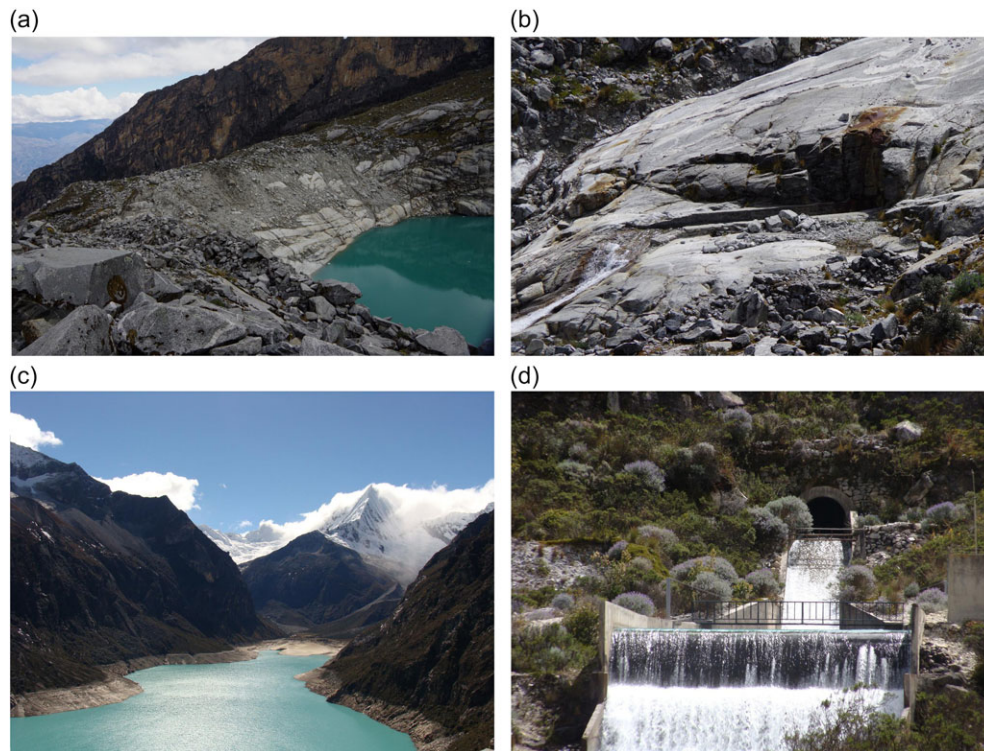
There are two examples of lakes equipped with tunnels dug through the moraine dam in the Cordillera Blanca, Lake Safuna Alta in the Collota Valley and Lake Tullparaju in the Quilcaynuanca Valley. Tunnels dug through the moraine material are generally susceptible to damage during large earthquakes. An example is the 1970 catastrophic earthquake resulting in tunnel damage and subsequent piping at Lake Safuna Alta (Lliboutry *et al.*, 1977; Hubbard *et al.*, 2005). There are two subtypes of tunnels dug through the bedrock – tunnels dug through the bedrock dams of bedrock-dammed lakes (Lake No. 513 in the Hualcán Valley (Figure 3(a), (b); see also Reynolds *et al.*, 1998) and Lake Cullicocha in the tributary of the de los Cedros Valley) and tunnels dug through the bedrock surrounding a moraine-dammed lake (Lake Parón in the Parón Valley; Figure 3(c), (d)). These constructions are generally considered to be more resistant to earthquakes.

**Figure 3** Examples of lakes equipped with tunnels. (a) A bedrock dam of Lake No. 513 partly covered by moraine material, and the debris-free bedrock indicates the original water level before being lowered 20 m; (b) the outlet of a tunnel dug through the bedrock dam of Lake No. 513; (c) an overview of Lake Parón from the Jatunraju glacier damming the lake (note the light belt around the lake indicating a decrease in the water level of about 40 m); and (d) the outlet of the tunnel below Lake Parón.

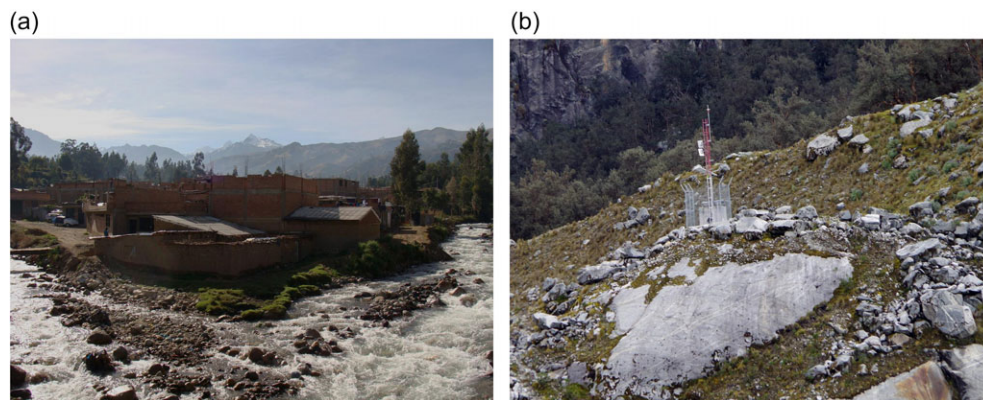
**Figure 4** GLOF vulnerability issue in the Cordillera Blanca, Peru. (a) Inappropriately located buildings on the confluence of the Quilcay River and Cojup Stream, Nueva Florida, Huaráz, Peru; (b) shows a transmission tower of the early warning system installed in the Chuchun Valley to warn the inhabitants of Carhuaz of a glacial lake outburst flood (GLOF) from Lake No. 513.
