NATURAL RISKS AND PROTECTION

# The Geomorphological Hazard of Machu Picchu Citadel and Aguas Calientes Village

Claudio Puglisi, Luca Falconi, Augusto Screpanti, Vladimiro Verrubbi, Guido Martini, Salvatore Paolini

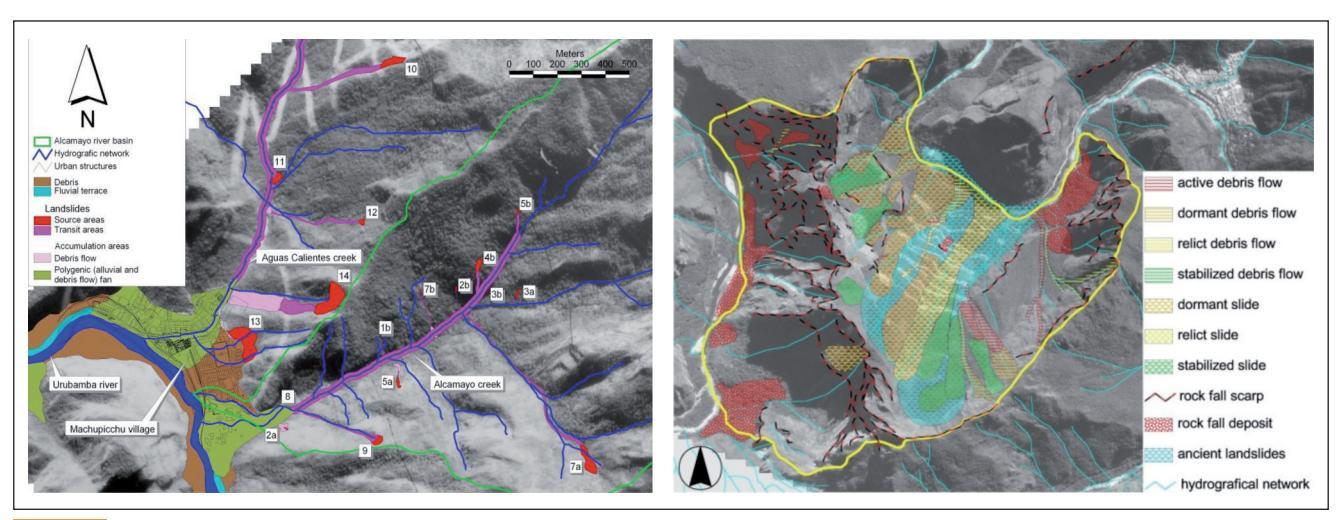
FIGURE 3 Landslides inventory in the areas of the Aguas Calientes village and the Machu Picchu citadel Source: ENEA

The Machu Picchu Sanctuary is regularly affected by several slope instability phenomena (Canuti et al. 2005; Carreño and Kalafatovich 2006; Vilimek et al. 2007; Carlotto et al. 2009; Puglisi et al. 2011): rock falls, high-angle rock slides, low angle rock slides and debris flows (Fig. 3). Kinematic conditions for landslide type and evolution are closely depending on structural and topographic factors. Besides the structural setting, rock falls and slides are highly dependent on the geomorphological evolution and anthropic activities and are mainly triggered by regional seismic activity. Instead, abundant local rainfall is the main triggering factor for debris flows due to the rapid saturation of the shallow portions of the soil layer.

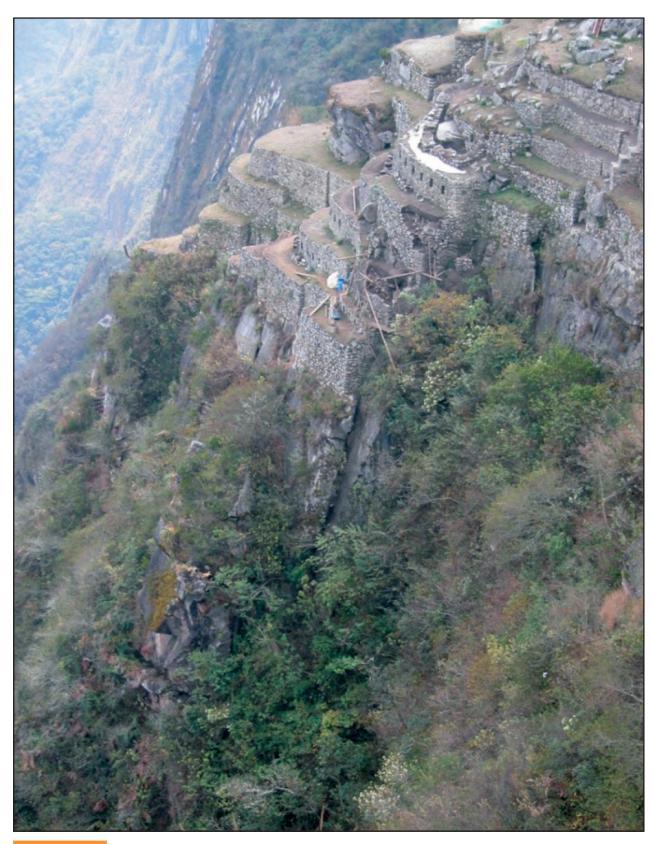
FIGURE 4 Open fractures in the SW flank below the Inca citadel Source: ENEA

Other landslides of type A are inside the citadel along the structural system with orientation  $30^{\circ}$  and slope  $30^{\circ}$ , but are currently inactive. Their activation can be dated before the citadel construction, being stabilized during the construction. Also the NE flank below the Inca citadel is affected by type A landslides, that develop prevalently along the  $30^{\circ}/30^{\circ}$  and  $30^{\circ}/60^{\circ}$ structural sets. The intersection of slope orientation with the structural system makes the slope evolution active with a retrogressive distribution of activities, with slow evolution. The entire SW side has an almost vertical slope and the pattern of joints is determined by the intersection between the  $225^{\circ}/65^{\circ}$  and  $130^{\circ}/90^{\circ}$ systems (Fig. 4). The frequent open fractures and the

current deformation of the archaeological structures (andenas) implies that type B landslides are active, and therefore the hazard related to this portion is high.

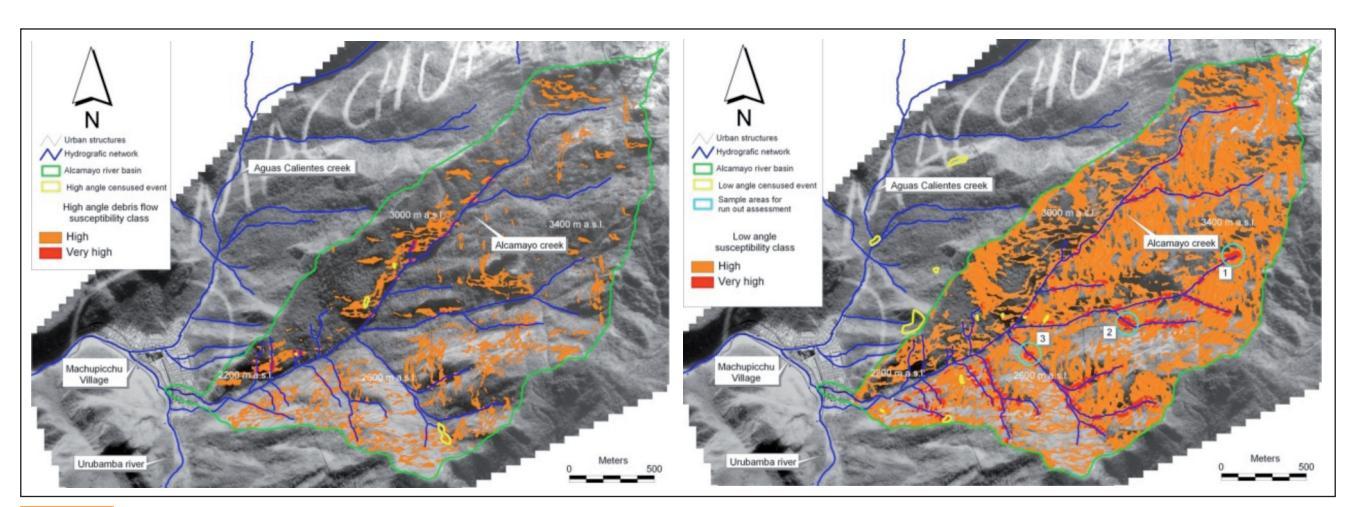
FIGURE 5 High angle (left) and low angle (right) debris flow hazard maps in the Alcamayo catchment above the Aguas Calientes village Source: ENEA

Comparing the landslide inventory and DEM derived maps, slope and aspect classes of the areas affected by landslides in the past have been identified. Two general trends for the source areas have been identified: high angle phenomena occurring on the steeper slopes  $(50^{\circ}-70^{\circ})$ , where soil is moderately thick, and low angle phenomena with thicker soil bodies lying on smoother slopes  $(25^{\circ}-55^{\circ})$ . Debris flow hazard maps of both types have been produced for the Alcamayo catchment (Fig. 5).

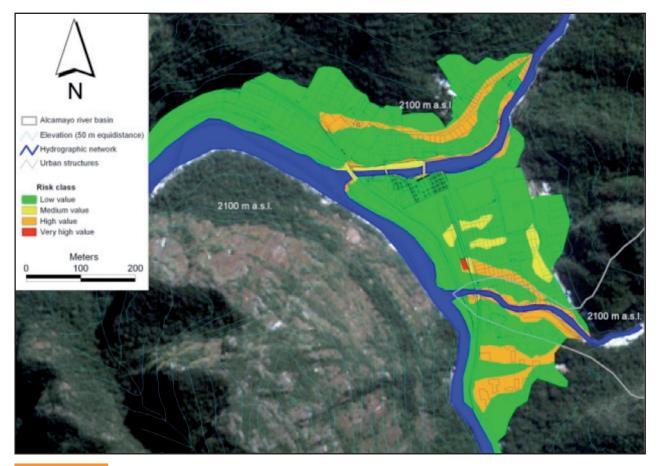
In the village of Aguas Calientes, buildings located in the morphological depression near the railroad station are in the higher risk areas (Puglisi et al. 2011; Fig. 8). Another important risk for the lower part of the village involves constructions on the banks, very close to the river water level. This scenario raises the damaging potential of the Vilcanota river floods. If a debris flow, originating from one of the tributaries, dams the river downstream of the village, the Vilcanota water level could increase and flood Aguas Calientes. Material accumulated by previous debris flows on the

FIGURE 8 Debris flow risk map in the Aguas Calientes village Source: ENEA
