Glacier Lake 513, Peru: Lessons for early warning service development

Article in WMO Bulletin · April 2020

By Christian Huggel¹, Alejo Cochachin², Fabian Drenkhan^{1,3,4}, Javier Fluixá-Sanmartín⁵, Holger Frey¹, Javier García Hernández⁵, Christine Jurt⁶, Randy Muñoz¹, Karen Price⁷, Luis Vicuña¹

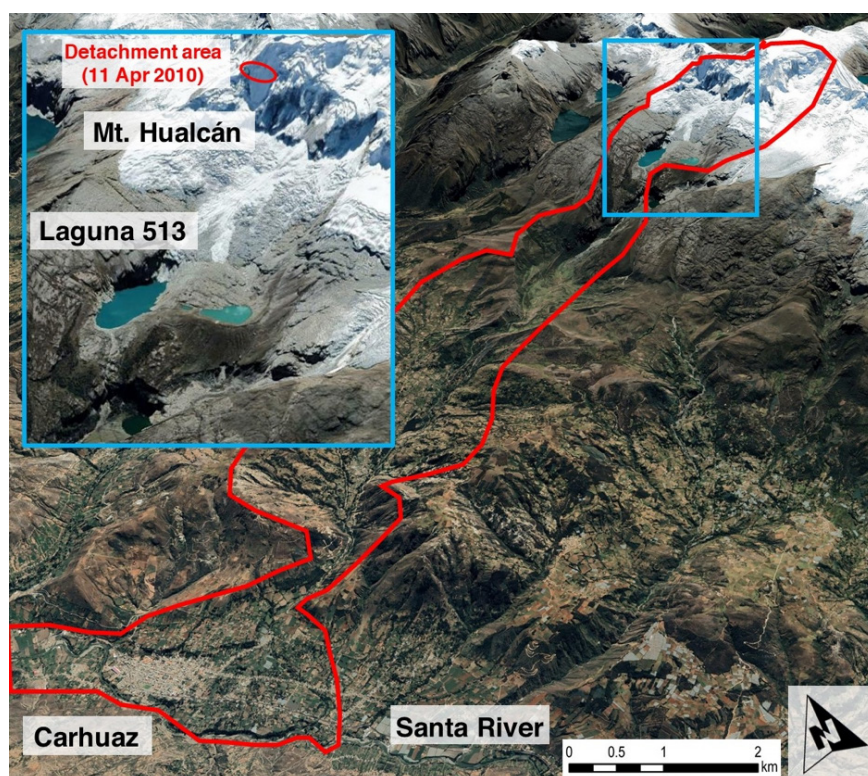
Overview map of Lake 513 and Carhuaz, indicating the 2010 ice avalanche source zone producing the GLOF that reached down to Carhuaz.

However, Laguna 513 was heavily impacted when a 450 000 cubic metres (m³) rock-ice avalanche detached from the southwest slope of Mt. Hualcán (Carey et al., 2012) (Fig. 2) on 11 April 2010, at about 8 a.m. local time. The avalanche caused a tsunami-like push-wave on the lake, resulting in a dam spillover despite the over 20 m freeboard. Traces of the wave indicate an overtopping of the dam by about 5 m – corresponding to a wave height of about 24 to 25 m – with a peak discharge of rate of several tens of thousands m³ per second (Schneider et al., 2014). The resulting GLOF damaged several bridges, water service infrastructure along its trajectory and eventually reached the debris fan of the city of Carhuaz (about 20 000 inhabitants), where the coarse material of the GLOF was deposited. A total of 0.7 km² of agricultural land was buried and the Santa Valley highway was affected, but no lives were lost.

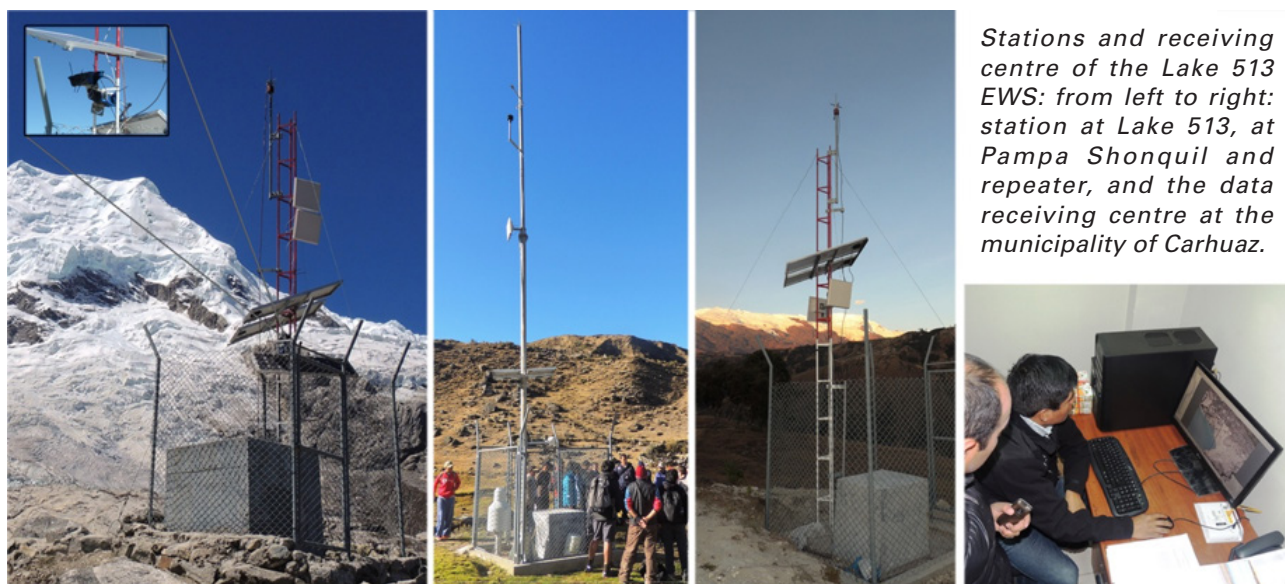
Stations and receiving centre of the Lake 513 EWS: from left to right: station at Lake 513, at Pampa Shonquil and repeater, and the data receiving centre at the municipality of Carhuaz.

With the knowledge and information gathered, the local and international team worked together, each contributing their expertise, to design an EWS that would overcome the challenges of Laguna 513. The design comprised two stations – a main station at the Laguna 513 dam and a station in the Pampa Shonquil,

which would include meteorological measuring instruments – a data centre in the municipality of Carhuaz, a warning station in the community of Pariacaca, and a repeater station for transferring the signal from the lake to the data centre (Fig. 3).

The stations were equipped with the following instruments:

1. Data centre Carhuaz (2 640 m a.s.l.): receiving antenna, screen with real-time data access, server for data storage, infrastructure for launching alarms.
2. Repeater station (3 189 m a.s.l.): receiving and sending antenna.
3. Station Laguna 513 (4 491 m a.s.l.): 2 cameras taking photos every 5 seconds during daylight times, one looking at the face of Mt. Hualcán, one observing the dam. 4 geophones located close to the station, continuously measuring and sending data in 5 second intervals, in order to detect potential mass movements (e.g. ice avalanche) impacting the lake. Receiving and sending antenna and data logger.
4. Station Pampa Shonquil (3 600 m a.s.l.): river discharge station (using pressure sensor), meteorological station with sensors for measuring
