ENGINEERING—GEOLOGICAL IMPORTANCE AND POSSIBLE ORIGIN OF THE STRESS RELIEF OF THE ROCKS OF THE CORDILLERA BLANCA, PERU

MENCL V., Professor, Research Engr., IGHP, Žilina, Czechoslovakia

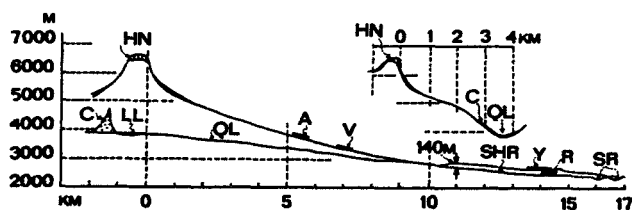
Fig. 3 - Longitudinal profiles of the paths of the Nevados Huascarán avalanches, which fell into the Santa Valley and into the Llanganuco Valley; HN - Nevados Huascarán, north peak, C - debris cone damming the stream draining the Laguna Alta (upper Llanganuco Lake); LL - lower Llanganuco Lake; QL - Llanganuco Valley & A - village of Armapampa; V - village of Vuelta; SHR - Shacsha Valley; Y - Yungay, R - Ranra-hirca; SR - RIO Santa (after LLI3OUTRY et al, 1970)

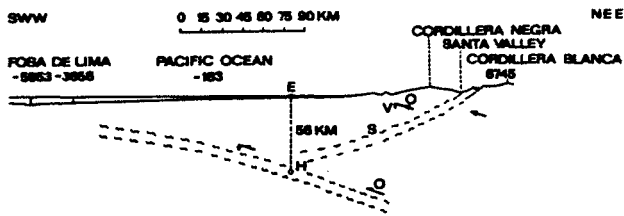
While the rock masses of unstable character are widespread throughout the mountains, it is interesting to observe how much the slope failures of the deposits filling the Santa valley are limited to the lines of recent faults. An important fault borders the western toe of the Cordillera Blanca. In reality it is a few kilometers wide zone (Fig. 8) in which the system of several faults developed. An assumption of the mechanism of the fault zone development is presented in Fig. 7. Although it is an attempt only, it may throw some light on the as yet unexplained (WILSON et al 1967, p.74) relative greater upheaval of the Cordillera Blanca as compared with that of the western region. It may also be helpful in explaining the deep stress relief of the rocks of the Cordillera Blanca.

Fig. 7 - Autor's conception of the mechanism of the development of the fault zone accompanying the Santa valley in Peru. The relative overthrust O of the continental crust (on the right) on the oceanic crust promotes gravity subsidence V of the latter. In reality the oceanic crust is underthrust beneath the continental crust (see e.g. DEWEY and HORSFIELD, 1970), but only the relative displacement is of importance in this case. Subsidence promotes slip movement S which gives rise to the fault zone. E , H - the epicenter and hypocenter of the May 31, 1970, earthquake.
