# Design Strategies to Mitigate Slope Instabilities in Structurally Complex Formations

Department of Materials, Environmental Sciences and Urban Planning, Università Politecnica delle Marche, 60131 Ancona, Italy

Due to the hilly morphology of the territory, the construction of two new road segments close to the Ionian coast of the Calabria region, southern Italy, required the execution of several excavations (trenches and tunnels), embankments and bridges to comply with the strict geometric prescriptions of modern standards for high speed roads. A large part of the work was to do with the Plio-Pleistocene over-consolidated clayey deposit, often known as the Blue Clay formation, that is outcropping along the East margin of Central and Southern Italy. This formation, constituted of a succession of grey-blue silty and marly clays with thin silty and sandy layers, exhibits very good mechanical characteristics, in terms of stiffness and strength, at the scale of the samples but, when considered as a whole, it becomes very weak because its mechanical response is governed by the presence of discontinuities along which the strength is typically at residual. As firstly pointed out by Esu

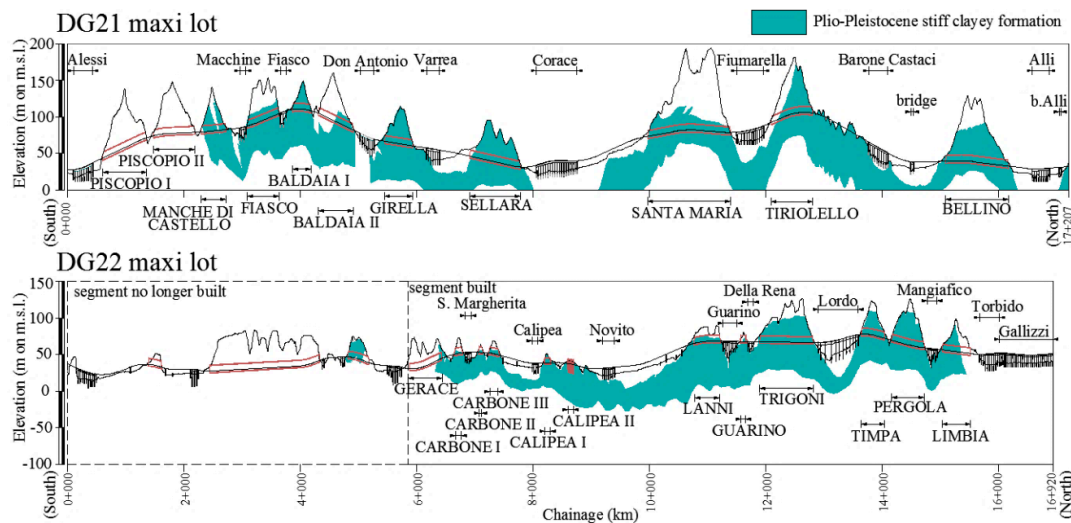
**Figure 2.** Longitudinal simplified cross-section of the DG21 and DG22 maxi lots with indication of viaducts, bridges (names in lower case in the figure), and tunnels (capital letters).

The most important engineering works for the DG21 mega lot include 11 twin-tube tunnels with total length of 7.9 km, 10 viaducts, 2 bridges, and 7 junctions; for the built segment of the DG22 mega lot, 5 twin-tube tunnels (total length 2.6 km), 7 “cut and cover” twin-tube tunnels, 7 viaducts and 3 junctions. Such works are outlined in Figure 2 through simplified longitudinal cross-sections, with indication of viaducts, bridges, and tunnels for the DG21 and DG22 segments, respectively. In the figure, the diffusion of Plio-Pleistocene clayey formation is highlighted in color.

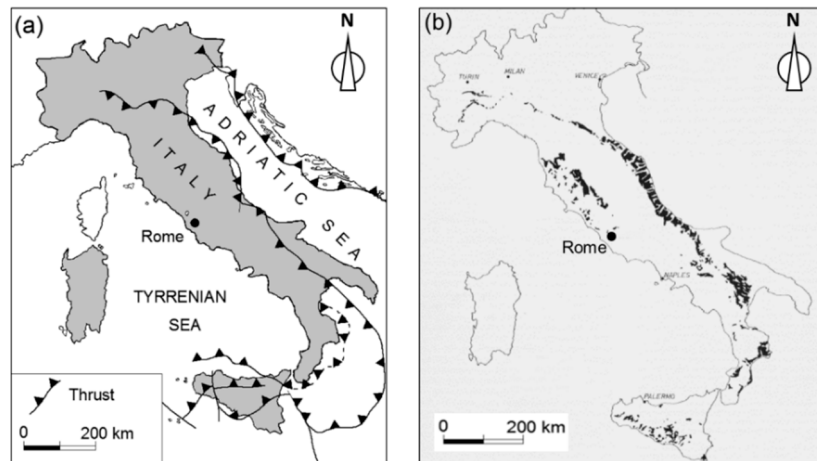
**Figure 3.** (a) Schematic structural map of Italy showing the current location of the Apennines accretionary wedge front (modified from Loreto et al. 2015 [48]); (b) Outcrops of Plio-Pleistocene marine clayey formation in Italy (modified from Manfredini et al. 1985 [46]).

Figure 3a shows a schematic structural map of Italy with the current location of the Apennines accretionary wedge front along which most of the currently Plio-Pleistocene deposits are found, either outcropping as showed in Figure 3b or underlying a few metres of recent continental sediments. The sequence has been affected by the Apennines' last uplifting phases, as shown by the elevations at which they outcrop in some zones of the Apennine. According to Manfredini et al. (1985) [46], Plio-Pleistocene deposits, although characterized by a sub-horizontal attitude, were affected by tectonic deformations of different extents as testified by the presence of faults with small throw. Along the Adriatic foredeep, for example, a main set of subvertical faults approximately perpendicular to the coastline, has cut the deposits into large block alternatively uplifted (corresponding to the present hills) and lowered (corresponding to the present valleys).

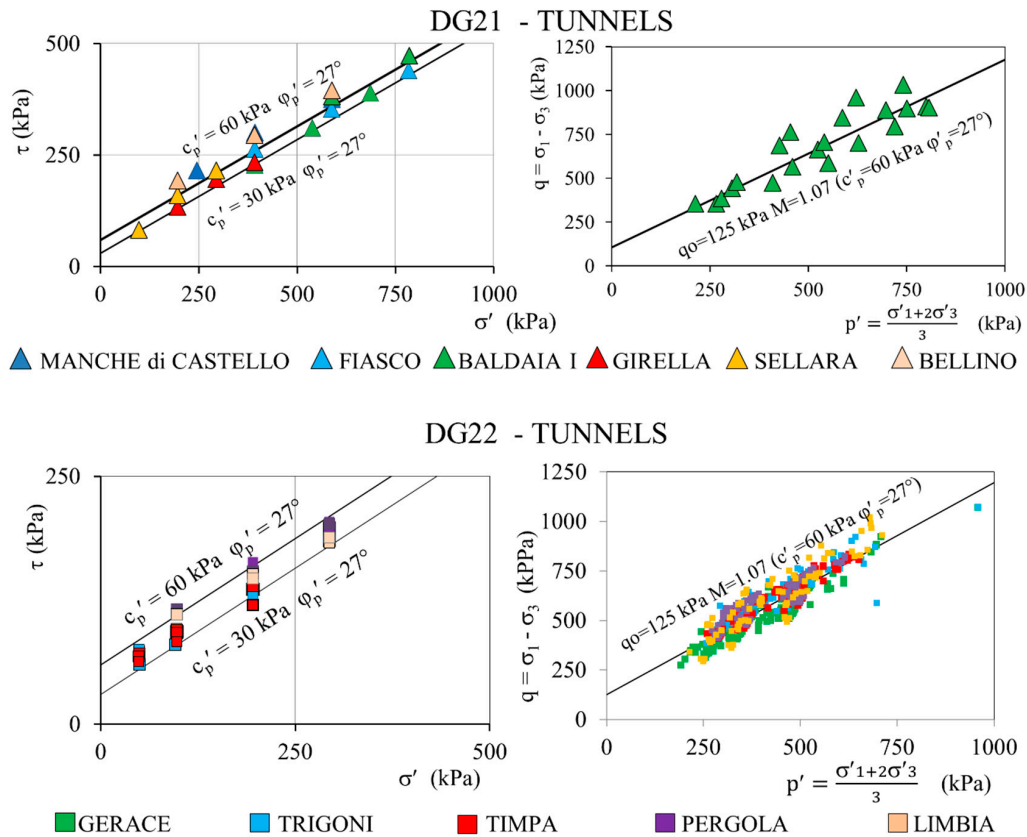
Figure 4. Peak shear strength obtained by laboratory tests on undisturbed samples from the DG21 and DG22 maxi lots.

The Plio-Pleistocene formations of the DG21 and DG22 maxi lots exhibit very similar geotechnical properties: in both cases, a grading with 40–50% of clay, 40–50% of silt, and 0–10% of sand was found; liquid limit ranges between 50 and 75 and Plasticity Index between 25 and 40, so that the soil classifies as high plastic clay (CH) or silt (MH), according to the Casagrande classification chart. Direct shear and triaxial compression tests, represented through Mohr-Coulomb and stress invariants envelopes, respectively, indicate that a linear effective strength envelope can be adopted with peak friction angle of  $\varphi'_p = 27^\circ$  and effective cohesion  $c'_p = 30\text{--}80$  kPa (Figure 4). Both pressuremeter and cone penetration

tests indicate that the undrained shear strength ( $c_u$ ) may vary between 200 and 400 kPa, although much higher values, up to 700 kPa, were occasionally found.

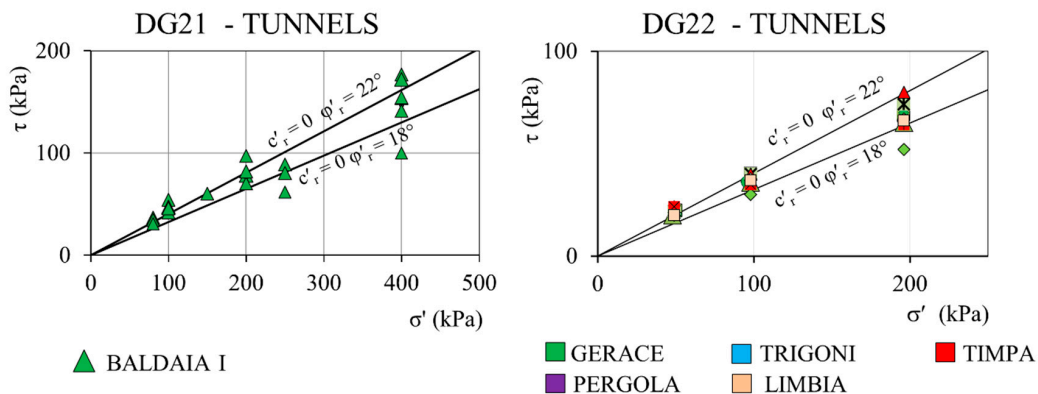
Figure 5. Residual shear strength obtained by direct shear testing on samples from the DG21 and DG22 maxi lots.

The shear strength at residual was obtained from direct shear tests after multiple shearing cycles. In Figure 5, the results of the most relevant tests in the Mohr-Coulomb stress plot are shown. Note that, in this particular condition, large part of the results agree with a purely frictional Mohr-Coulomb failure envelope, described by a friction angle of  $\phi'_r = 18\text{--}22^\circ$ . Values of slightly smaller residual friction have been found through the Bromhead’s ring shear apparatus, but the scarcity of tests does not allow a clear distinction between the values. In conclusion, a single representative residual friction angle of  $20^\circ$  is considered appropriate for the Plio-Pleistocene formation.

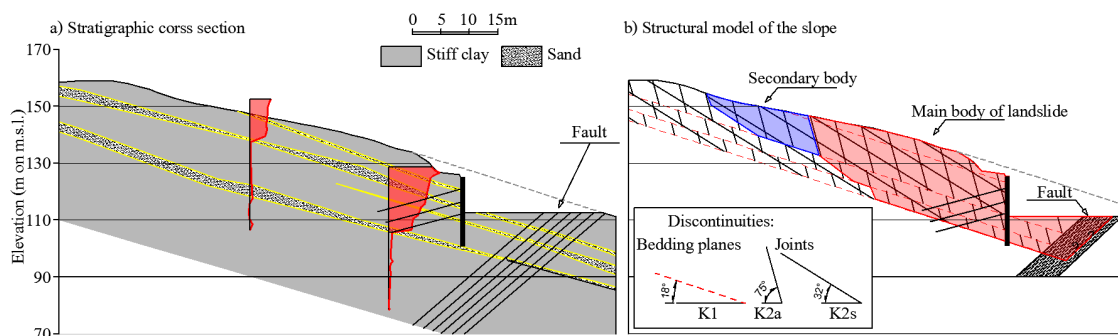
**Figure 6.** (a) Stratigraphic cross-section of the slope with the most significant inclinometer readings; (b) structural model of the slope with indication of the landslide bodies.

In Figure 6a, a schematic representation of the cross-section of the slope in the area of the southern portal is shown with the most significative inclinometer profiles and the typical arrangement of the Plio-Pleistocene formation with the sandy layers sometimes included. The bedding planes are approximately parallel to the sloping angle, that is equal to 18°. At the toe of the slope a fault was detected dipping towards the slope itself. The fault had deformed and altered the geological setting in the area. In Figure 6b, a simplified scheme of the structural model of the slope is given to bring to attention the two soil bodies involved in the instability. It can be observed that the displacement of the soil mass, evidenced by the inclinometers, takes place along the bedding planes.

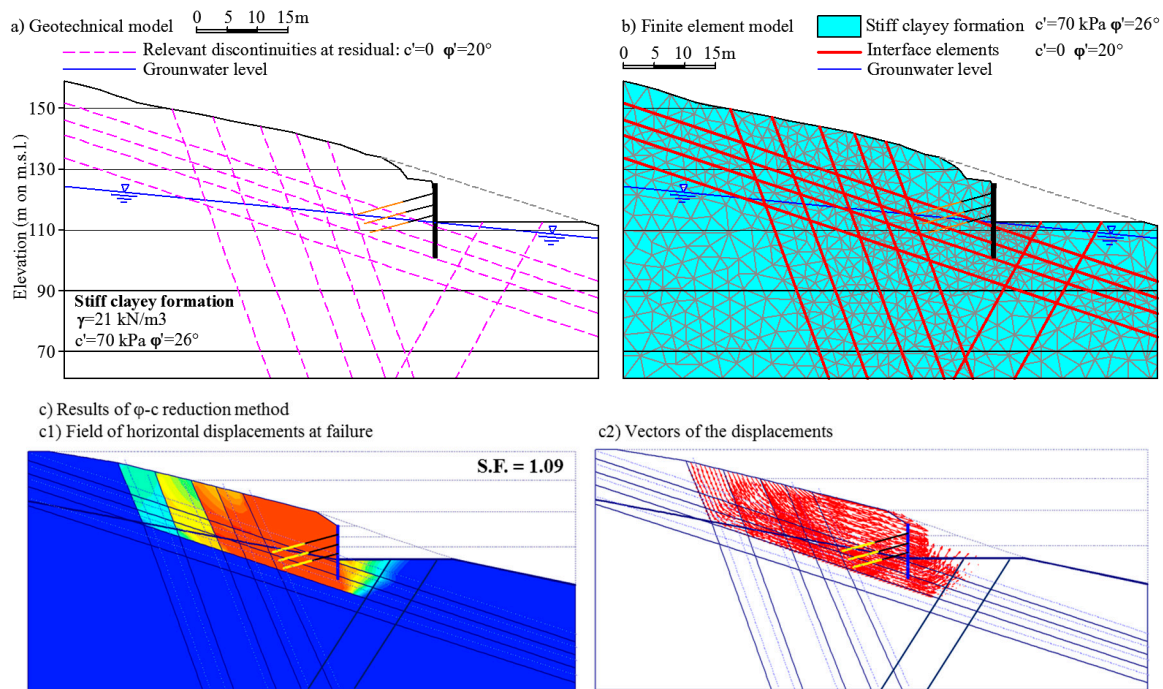
**Figure 7.** Slope stability analysis at the Baldaia I southern portal: (a) Geotechnical model; (b) Finite element model; (c) Results of the  $\phi$ -c reduction method in terms of horizontal displacements at failure (c1) and vectors of the displacements (c2).

In Figure 7a,b, the reference geotechnical model and the correspondent calculation model for slope stability analysis are shown. It can be observed that the slope has been modelled as a uniform body of stiff clay interrupted by some discontinuities, which represent the main geological structures influencing the behaviour of the slope. The position of the groundwater level was determined by piezometer readings. Taking into account the presence of sub-horizontal drains from the retaining wall and the drainage exerted by the tunnel, it is reasonable to consider the groundwater level assumed in the model as stable in time. The slope was analyzed by means of a finite element model built with 15-node triangular elements and implemented through the commercial code Plaxis 2D (Bentley Systems, Inc., Delft, The Netherlands). The software allows the modelling of discontinuities as “frictional interfaces” where relative displacements (slipping/gapping) between separate parts of the mesh are admitted. The stiff clay was represented by means of an elastic perfectly plastic constitutive model with strength according to the Mohr-Coulomb failure criterion in terms of effective stresses, with cohesion  $c' = 70$  kPa and friction  $\varphi' = 27^\circ$ . Based on triaxial test results on undisturbed samples at an operative strain level, a Young modulus equal to 70 MPa and Poisson’s ratio 0.3 were assumed to characterize the elastic response of the model. Interfaces are characterized by a purely frictional behavior with an effective friction angle  $\varphi' = 20^\circ$ . This last value represents the residual strength along the discontinuities resulting from experiments. The numerical modelling of the slope was carried out in steps reproducing the in-situ initial condition, the construction of the geotechnical structure (retaining wall and ground anchors), and the progression of excavation. Failure of the slope was reproduced by a progressive reduction of the soil strength parameters according to the well-known  $\varphi$ -c reduction technique: a safety margin of 1.09 was obtained from the numerical analysis (Figure 7c), thus confirming the close-to-failure condition of the real slope. Moreover, in Figure 7c1, the field of horizontal displacements in the failure zone is highlighted. By analyzing the vectors of displacements (Figure 7c2), the kinematics of the slope resulting from the modelling strongly resembles the picture emerging from inclinometer profiles, with a clear sliding of the blocks along the discontinuities. Having the numerical model given a sufficiently reliable representation of the deformation mechanism occurring at Baldaia I, it was possible to conceive and implement the necessary remedial measures. These aimed both at restoring the safety of the slope and allowing the completion of the works by means of a large filling at the toe of the slope to impede its movements. Considering that the filling substantially restored the original stress of the slope and that the formation is heavily overconsolidated, it is possible to exclude the development of excess pore pressures able to influence the stability of the slope. An elongation of the tunnel was first necessary, which was executed by adopting a “cover and cut” methodology. Figure 8a shows a picture of the Baldaia I southern portal soon after completion of the refilling. Figure 8b shows the safety margin resulting from a failure analysis of a model of the slope that included the effect of the remedial measures. An increasing of the safety factor up to 1.4 was observed. It can be seen from Figure 8b that the critical mechanism is much more extended than the one before the remedials and that the discontinuities involved in the failure are much longer, thus contributing to the increase of the safety margin of the slope.

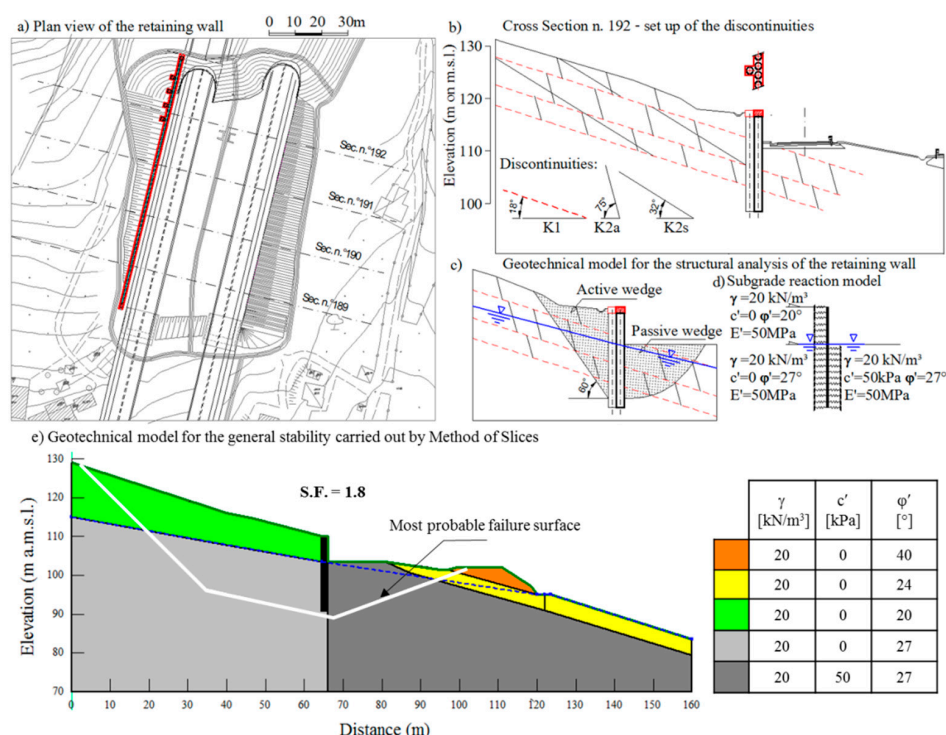
**Figure 9.** (a) Plan view of the area of interest with the position of the retaining wall; (b) cross-section n. 192 with the pattern of the main families of discontinuities; (c) geotechnical model for the structural analysis of the retaining wall (compare the pattern of discontinuities with active and passive wedge); (d) subgrade reaction model used to design the retaining wall (note the different strength parameters adopted to take into account the discontinuities); (e) geotechnical model adopted for general stability of the retaining wall.

In Figure 9d, the subgrade reaction model adopted for pile design is shown. An operative Young modulus equal to 50 MPa was appropriate to account for the soil properties and the average strain level around the excavation.

In Figure 9e, the geotechnical model used to evaluate the general stability of the slope after the excavation is shown. Note that the most probable failure surface was searched for by using the “block specified techniques”. This technique is a particular application of the Method of Slices in which the slip surface is divided into three segments and is suited for critical mode of failure when significant structural features of the ground or weak layers with known orientation are present, as in this case study.

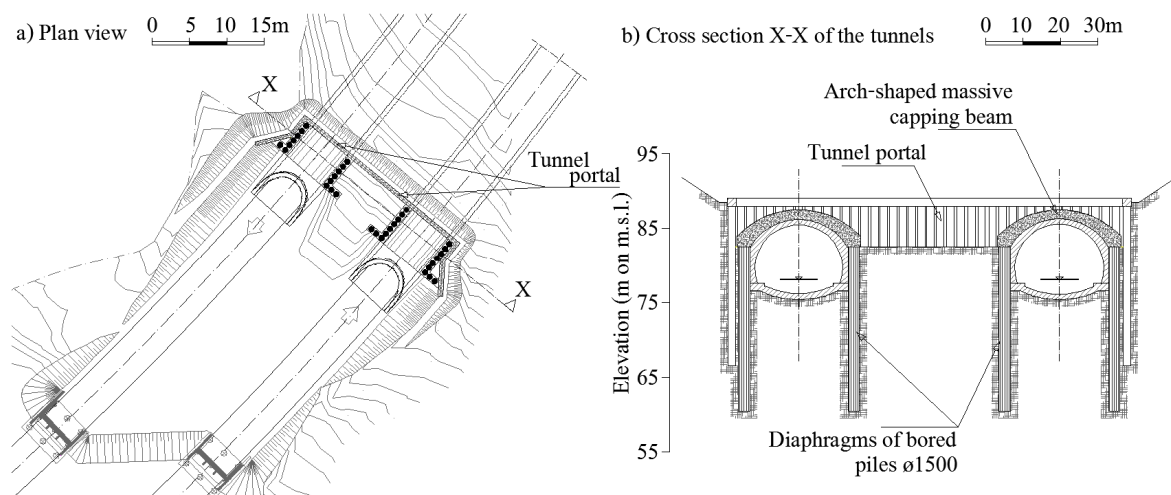
**Figure 10.** (a) Plan view of the Timpa southern entrance; (b) cross-section X-X of the tunnels.

Figure 10a shows a plan of the Timpa southern entrance, where it is possible to distinguish the bored piles of the tunnel portal from those built for the foundation of the massive capping beam. In Figure 10b, a cross-section of the tunnels with highlighted components of the portals (diaphragms of bored piles  $\varnothing 1500$  and arch-shaped massive capping beam) is shown. It is evident from the figure that this solution allows to reduce the span of the excavation at the tunnel entrance from about 15 m to 5 m.

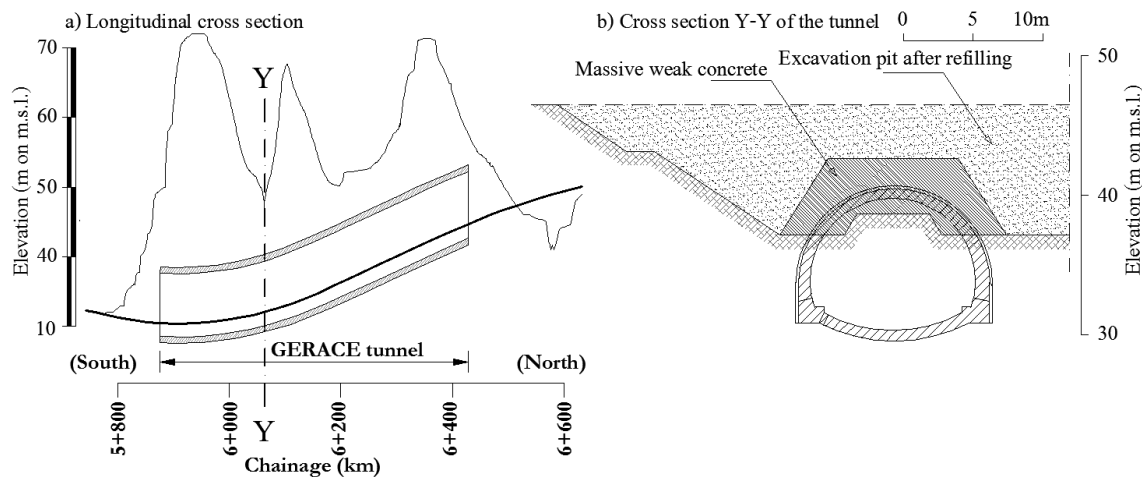
**Figure 11.** (a) Longitudinal cross-section of the Gerace tunnel; (b) Cross-section Y-Y of the tunnel.

The Gerace tunnel intersects three little hills for a length of about 450 m (see Figure 11a). At a chainage of 6+100 km, the tunnel crosses the lowest point of a steep valley, with minimum cover of 6–8 m. This segment was particularly sensitive due to the low cover that impedes the full development of the arching effect. In this condition, designs typically provide a strong pre-support intervention

using the fore-pole umbrella system. The designer, however, proposed to carry out a reinforcement of the soil above the tunnel crown. As shown in Figure 11b, the reinforcement consisted of a large excavation up to the shoulders of the future tunnel and the construction of a massive block of weak concrete set-up to reproduce the shape of an arch segment. The excavation was then refilled with soil up to the original ground level. The methodology adopted as a preventive outer support allowed efficient and safe progression of the tunnel excavation; however, the environmental impact is significant and the excavation along the entire valley is only possible in the absence of buildings or river channels in the zone of intervention.

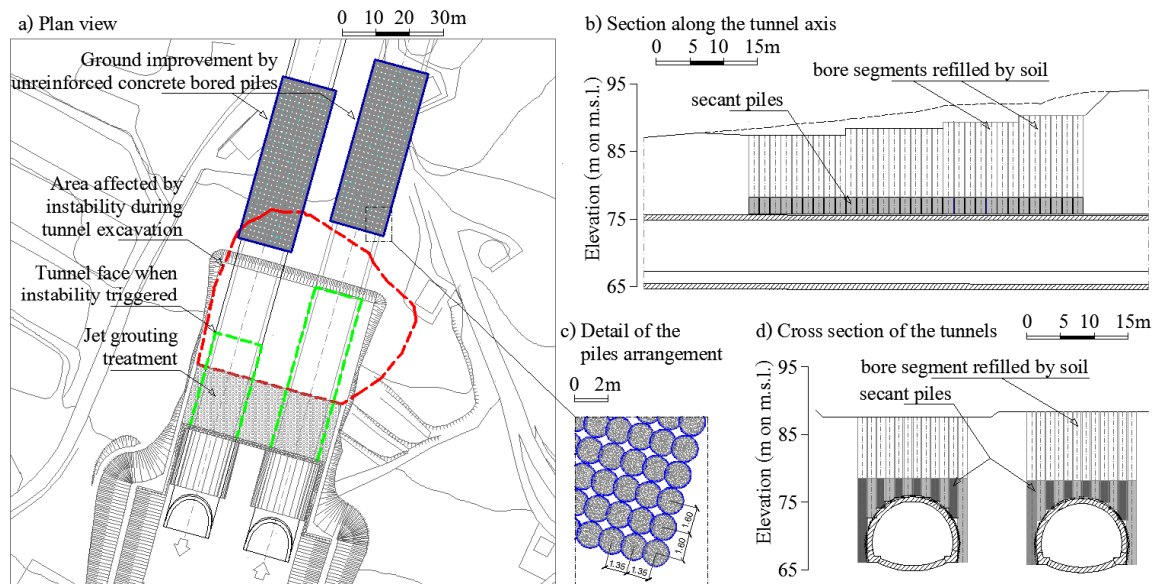
**Figure 12.** (a) Plan view of the Trigoni tunnel close to the southern entrance; (b) Section along the axis of a tunnel with the arrangement of concrete columns; (c) Detail of the pile arrangement; (d) Cross-section of the tunnels with the arrangement of concrete columns.

Ground improvement by rigid inclusions is a technique sometimes used to reinforce the ground before execution of a tunnel in structured formations. The possibility of working from outside, as offered by this technique, is particularly convenient, because it is known that costs of underground activities are several times higher than those of ordinary works. Minimizing expensive underground works ensures wide economical margins for the implementation of extensive treatments from the outside. A good example of application of this technique is the ground reinforcement carried out for the southern entrance of the Trigoni I tunnel along DG22. Difficulties in excavation were anticipated because a thick, incoherent Quaternary deposit lied on the Plio-Pleistocene formation at the tunnel entrance. In this particular case, jet grouting treatment of the incoherent soil helped overcome the difficulty, and subsequent excavation proceeded within the Trubi formation, with an average ground cover of about 10 m. To allow the excavation, the designer prescribed a primary lining made of an open ring of reinforced shotcrete (0.2–0.3 m thick) and steel cradles (2 coupled I bars IPN220 each 0.75 m). An umbrella of 48 sub-horizontal fore-poles over the tunnel crown and 60 fiberglass dowels were used as stabilizing measures at the front. After excavating some tens of meters, an instability phenomenon occurred, probably caused by the yielding of the soil pillar between the two tunnels. As indicated in Figure 12a, the instability involved both the tunnels and propagated up to the ground level, where tension cracks and huge settlements were detected. The cause of the failure was related to the arrangement of the discontinuities that affected the Pliocene-Pleistocene formation. Details about this event can be found in Segato et al. (2015) [31]. To overcome this second drawback, a ground improvement intervention was adopted, whose geometrical characteristics were such that an “arching effect” was activated. As shown in Figure 12c, the ground reinforcement consisted of a number of unreinforced concrete bored piles, 1.5 m diameter, arranged in square array  $1.35 \times 1.60$  m. Only the segment of the bores close to the tunnel lining was concreted, whereas the remaining portion was refilled by soil. The piles were secant along the transversal cross-section to form a structural massive arch above the tunnel with thickness of 2–3 m. Moreover, as shown in Figure 12b,d, by varying the

length of the piles, a complete shell around the crown was shaped, which included the shoulders and sidewalls of each tunnel. After the treatment, the underground excavation proceeded quickly with a relatively light primary lining consisting of an open ring of reinforced shotcrete (0.2 m thick) and steel cradles (2 coupled I bars IPN180 each 1.20 m).
