# Glacial Lake Outburst Floods (GLOFs) in the Cordillera Huayhuash, Peru: Historic Events and Current Susceptibility

**Abstract:** The aim of this paper is to create a glacial lake inventory for the Cordillera Huayhuash in Peru and to evaluate the susceptibility of lakes to the generation of glacial lake outburst floods (GLOFs). Using high-resolution satellite images, we undertook qualitative and quantitative analysis of lake type, characteristics and distribution, and placed our findings within the context of existing Peru-wide lake inventories. We also mapped and analyzed past GLOFs, revealing a total of 10 GLOFs and 4 ambiguous events, most of which have not been reported before. We found that past GLOFs usually occurred as a result of moraine dam breach during the proglacial stage of lake evolution. Further, we used our lake inventory to evaluate GLOF susceptibility of all lakes larger than 20,000 m<sup>2</sup>. Of 46 evaluated lakes, only two lakes (Lake Tsacra and Lake W014) are currently susceptible to generating a GLOF, which would most likely be through dam overtopping resulting from a flood originating in smaller lakes located upstream. The future perspectives of lake ev

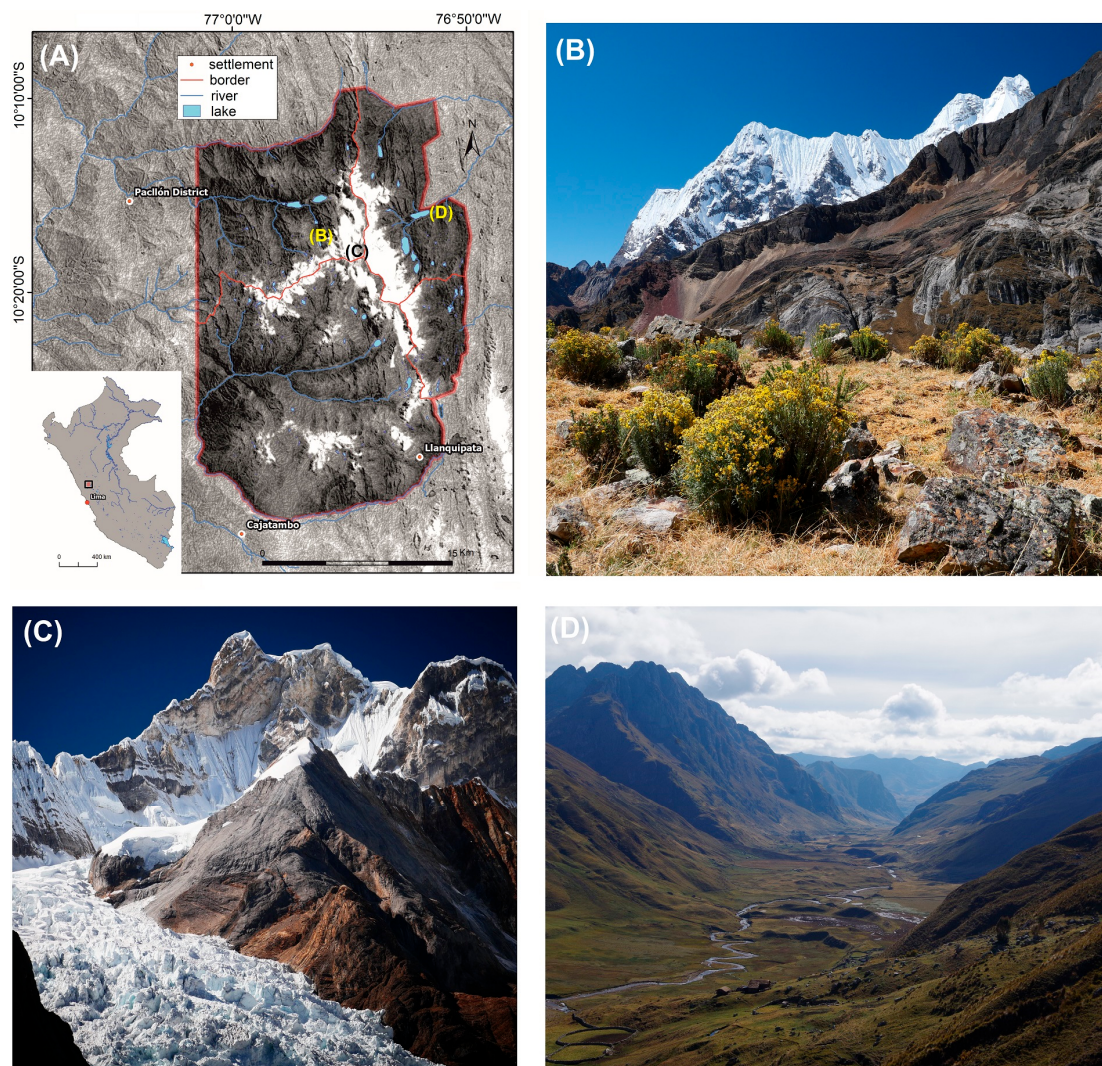
**Figure 1.** Study area. (A) The location of the study area Cordillera Huayhuash in Peru; (B), (C) and (D) diverse environmental conditions in different parts of the study area (for location see (A)). Field images were taken in 2018 and 2019 by AE.

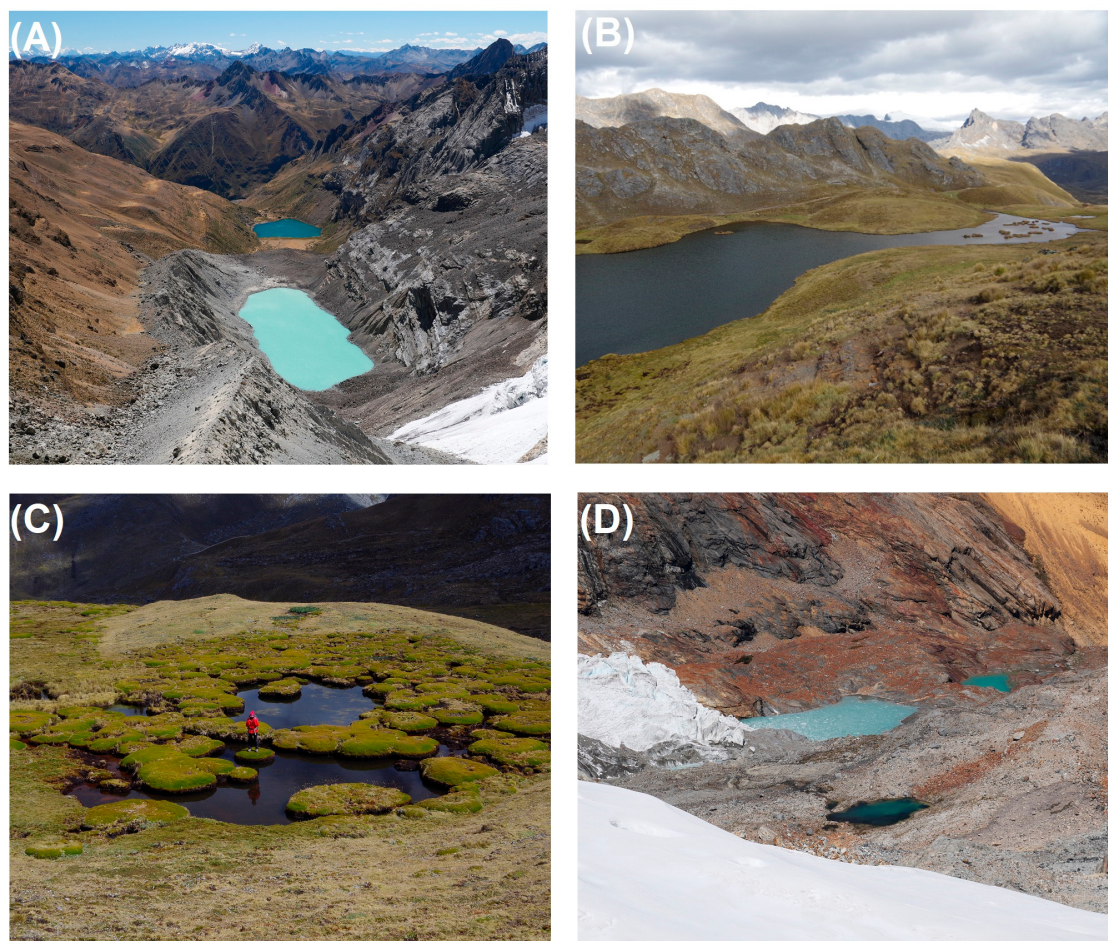
**Figure 2.** Different lake types present in the Cordillera Huayhuash. (A) Moraine-dammed lakes Barrosacocha (upstream, W006) and Rasaqcocha (downstream, W005); (B) large bedrock-dammed Lake Huaracacocha (E012); (C) an example of relict ('pampa' type) lake near the Siula Punta; and (D) a small moraine- (in front) and two bedrock-dammed lakes (one of which is proglacial) near the Rasac Punta. All images were taken in 2018 and 2019 by AE.

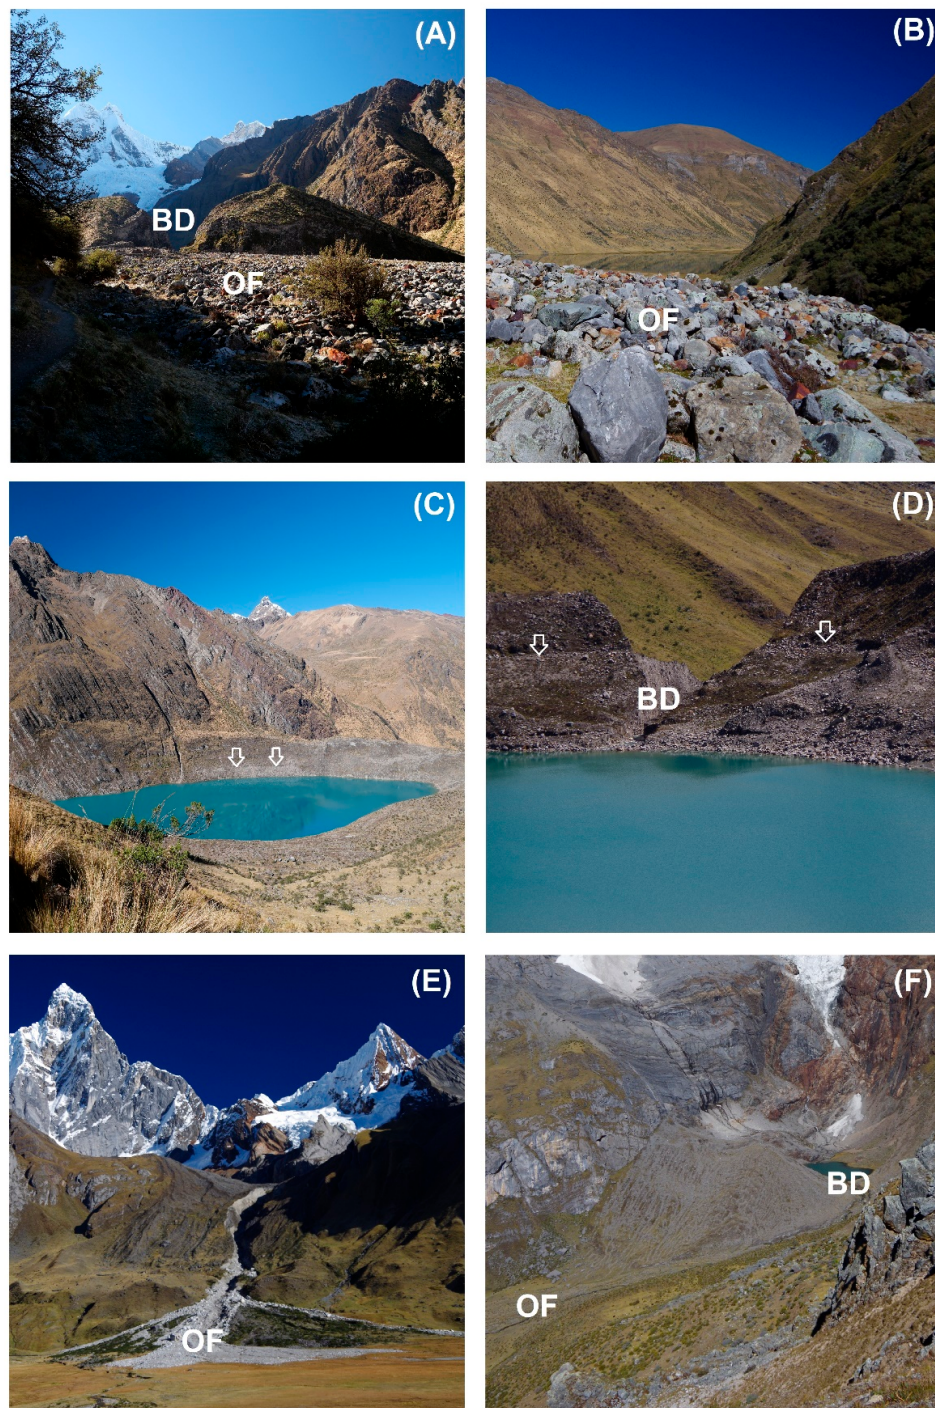
**Figure 3.** Examples of diagnostic features of past glacial lake outburst floods (GLOFs) in the Cordillera Huayhuash. (A) Upstream view on breached moraine dam (BD) of Lake Solteracocha (in centre background) with outwash fan located directly downstream from the dam (OF); (B) downstream view over this outwash fan (OF), the largest boulders are > 2 m in diameter; (C) visible evidence of Solteracocha pre-GLOF lake water level (arrows; GLOF in 1932); (D) downstream view through breached moraine dam (BD) of Lake Gangrajanca and pre-GLOF lake water level (arrows); (E) fresh outwash fan (OF) of recent ambiguous event associated with lake Chaclan; (F) breached moraine dam (BD) and partly vegetation-covered outwash fan (OF) of Unnamed lake (W032). All images were taken in 2018 and 2019 by AE.

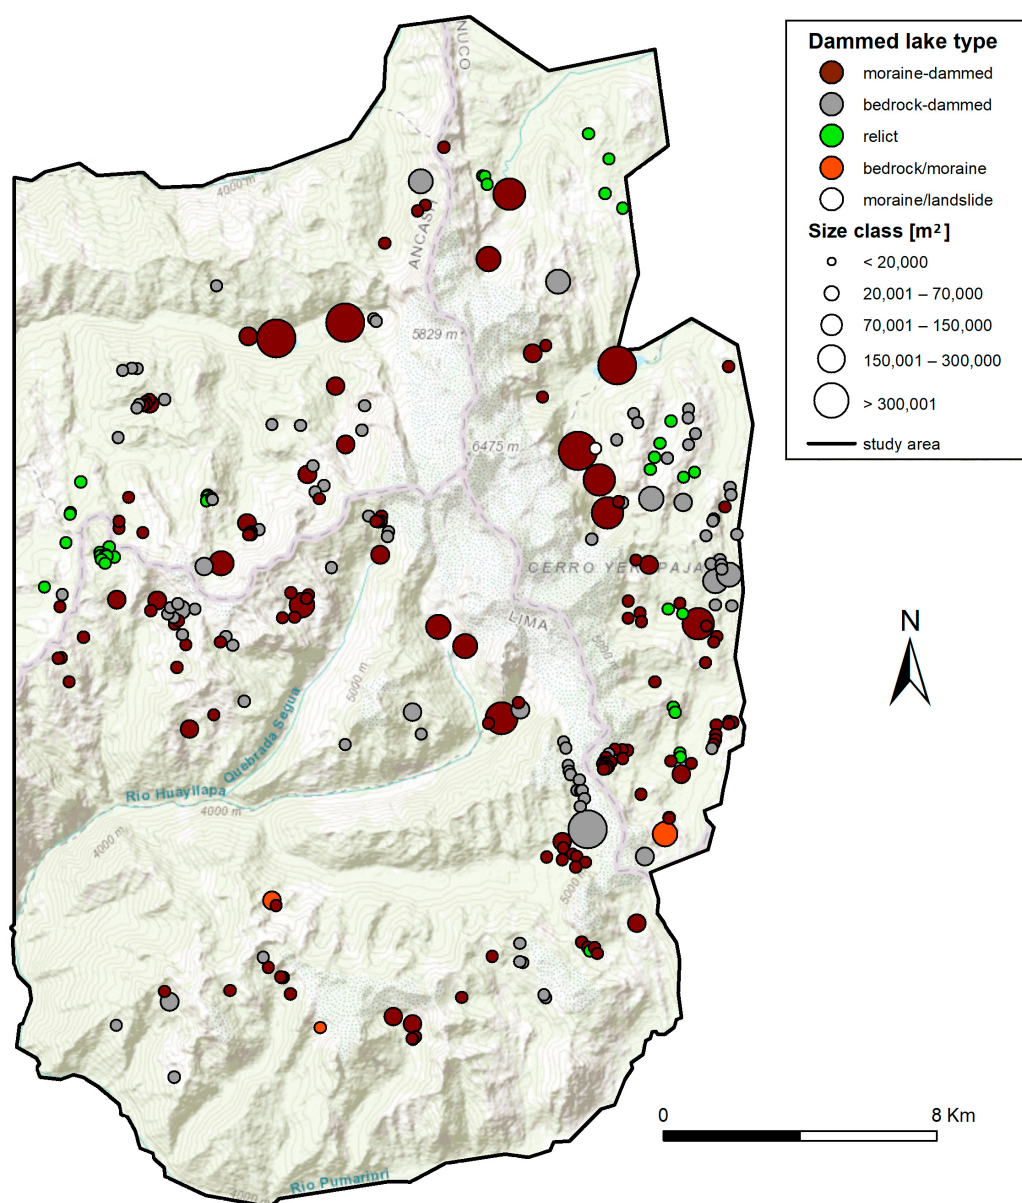
**Figure 4.** Lake inventory of the Cordillera Huayhuash with lake dam types (see Section 2.1 and Figure 2) and lake sizes. Background map: [40].

We have mapped 270 lakes (a total area 6.31 km<sup>2</sup>), of which 167 (total area 3.16 km<sup>2</sup>) are located in the western part of the study area, and 103 (total area 3.15 km<sup>2</sup>) are located in the eastern side (see Table 2; Figure 4). A total of 137 lakes are classified as moraine-dammed, 92 as bedrock-dammed, 37 are relict, 3 lakes have combined dam (bedrock + moraine) and one lake is dammed by moraine in combination with debris flow deposition. Basic characteristics of mapped lakes with regard to area, elevation, presence/absence of surface outflow, glaciers in the catchment, and direct contact with glacier ice are shown in Table 3; for the lake axis orientation, see Supplementary Materials Table S1.

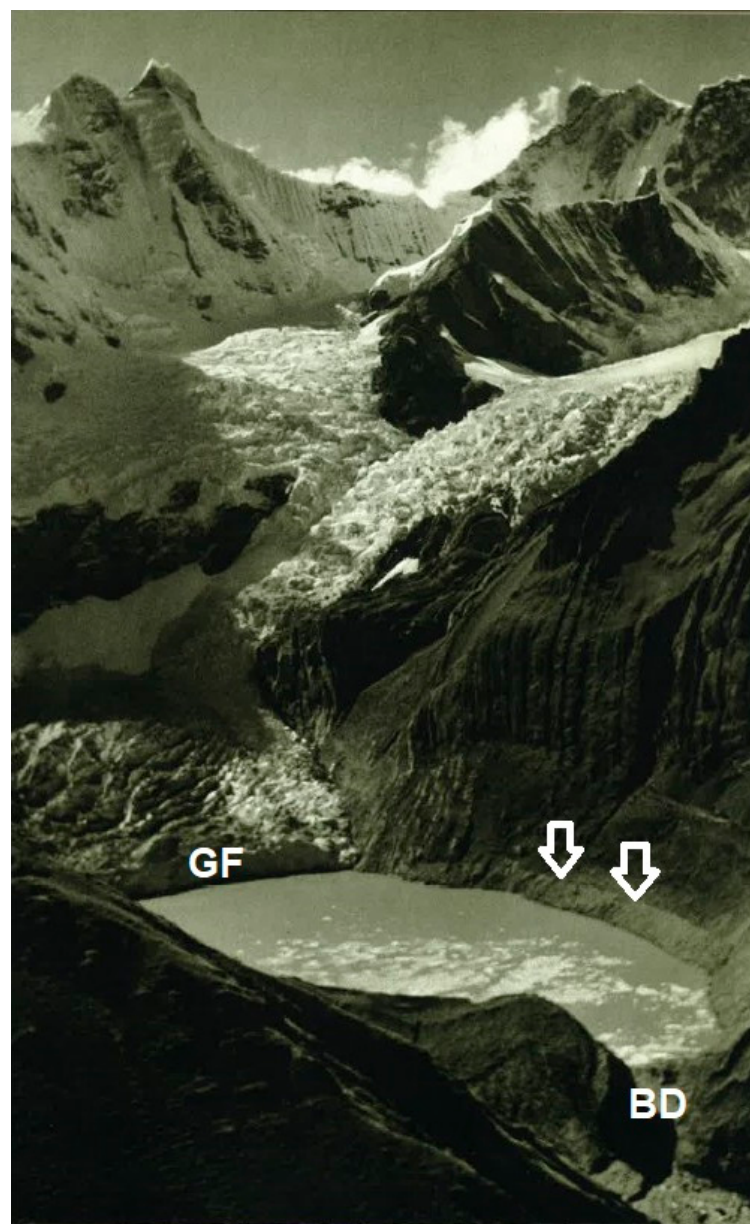
**Figure 5.** Lake Solteracocha in the 1930s (most likely in 1936), shortly after dam failure in 1932. Breached moraine dam (BD) is visible in lower right corner; arrows indicate pre-GLOF lake water level (also visible on Figure 3C). Note that the lake was still proglacial at the time (GF—glacier front). Image modified from [9].

Little is known about the preconditions and triggers of these GLOFs. Historical field images from Austrian–German expeditions carried out in the 1930s, as well as satellite remote sensing imagery, nevertheless reveal some details of these events. Strikingly, most of the current glacier-detached, large moraine-dammed lakes were proglacial at the time of the GLOF (often proglacial in the first post-GLOF image available). For instance, Lake Solteracocha was proglacial several (tens of) years after dam failure (see Figure 5).

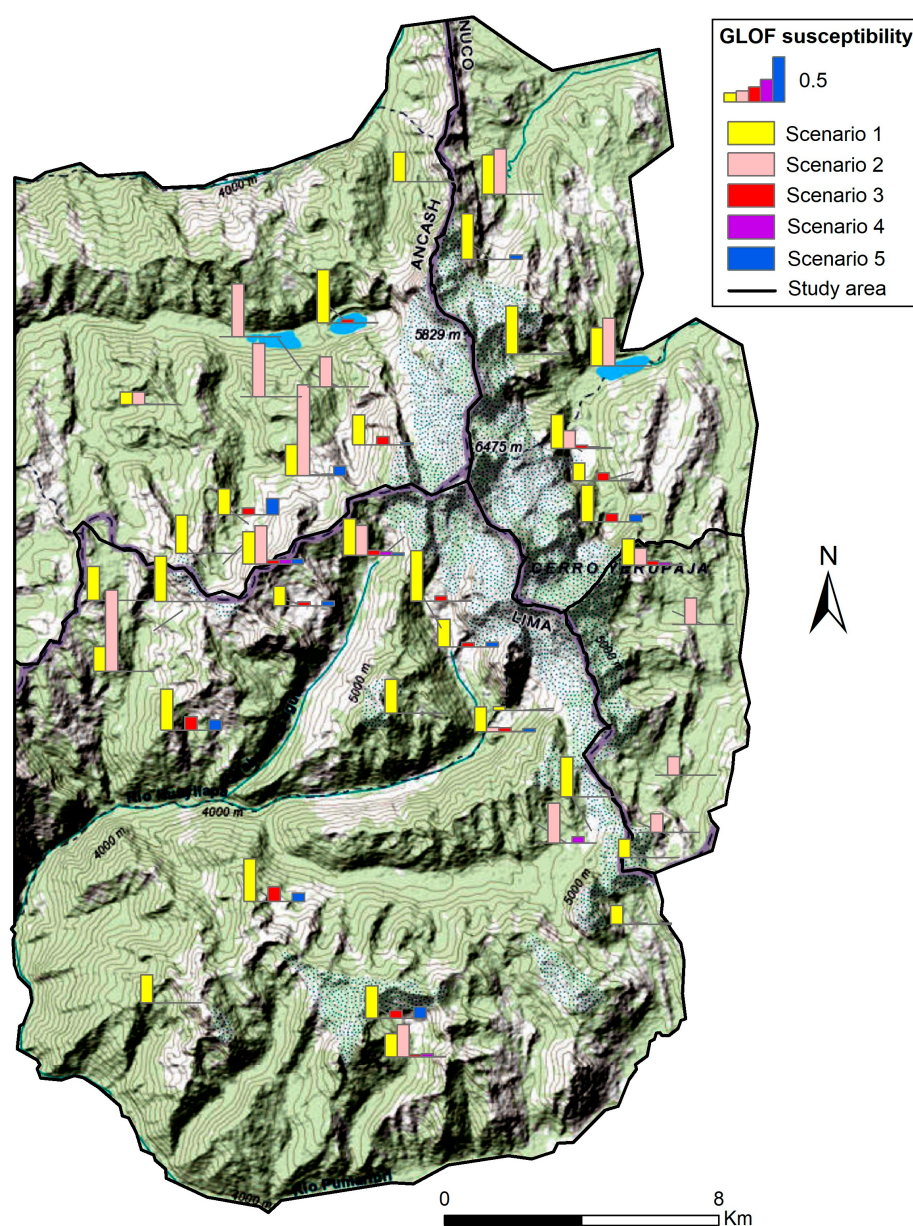
**Figure 6.** Map of the GLOF susceptibility of 46 large lakes (>20,000 m<sup>2</sup>) of the Cordillera Huayhuash. Background map: [40].

The vast majority of lakes of the Cordillera Huayhuash have low susceptibility to generating GLOFs (Figure 6; Table S2). Table S2 further shows that the most frequently expected GLOF scenario in the Cordillera Huayhuash is the dam overtopping due to rapid slope movement into the lake (Scenario 1), followed by the scenario of dam overtopping due to flood wave impact from a lake located upstream (Scenario 2). The susceptibilities of other scenarios rarely exceeded the threshold of negligible values. Out of the 46 evaluated lakes, only two exceeded high susceptibility thresholds, both in Scenario 2. These are Lake Tsacra (W007) and Lake W014. The width of the calving front exceeds the lake width in both cases, which is the main factor increasing susceptibility to GLOF (together with surface outflow, i.e., 0 m dam freeboard). Five lakes were found to have medium GLOF susceptibility for Scenario 1 and four other lakes for Scenario 2. Dam failures (Scenarios 3, 4 and 5) appear unlikely in the Cordillera Huayhuash, considering the fact that the majority of steep-sloped moraine dams that retain large lakes have already failed (see Sections 3.2 and 4.2).
