## **HIGH-MOUNTAIN HAZARDS IN A WARMING WORLD**

John J. Clague

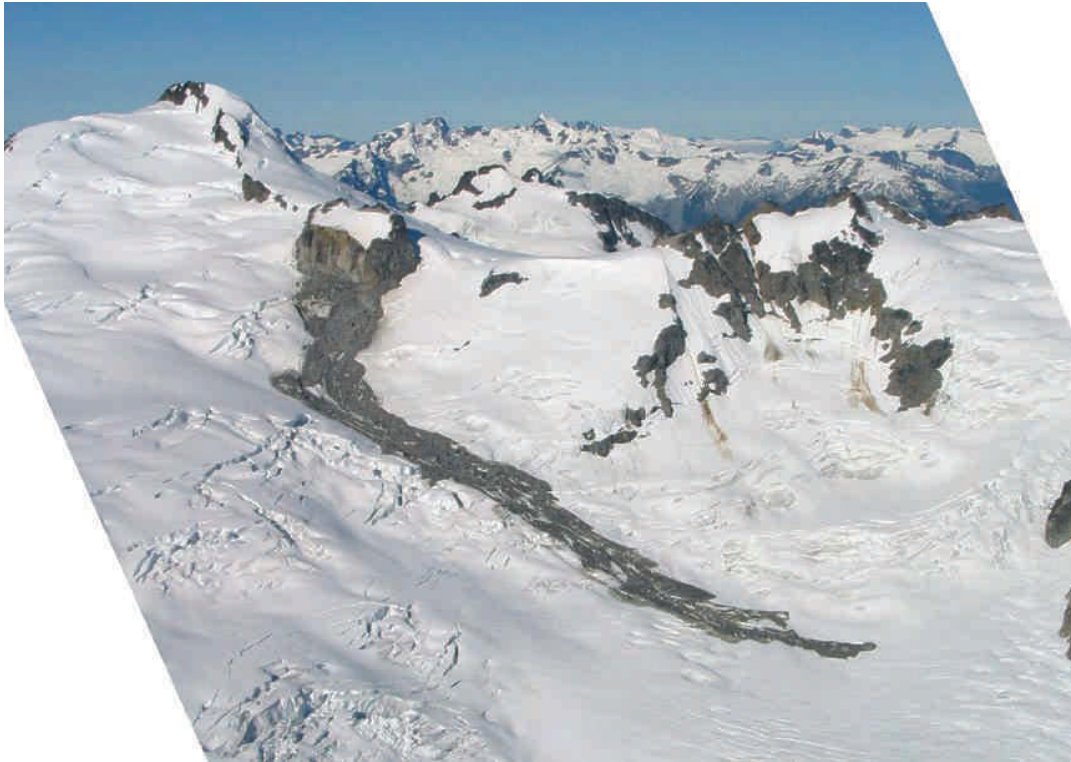
*Figure 1. A rock avalanche triggered by glacier debuttressing in the southern Alps of New Zealand.*

Recent glacier retreat may be responsible for some landslides in high mountains. Many marginally stable slopes that were buttressed by glaciers during the Little Ice Age failed after they became deglaciated in the 20<sup>th</sup> century (Figure 1). This effect is most pronounced in mountain ranges with the greatest contemporary ice cover – the Himalayas, St. Elias Mountains, and Coast Mountains – because these are the areas where ice losses in the 20<sup>th</sup> century have been largest.

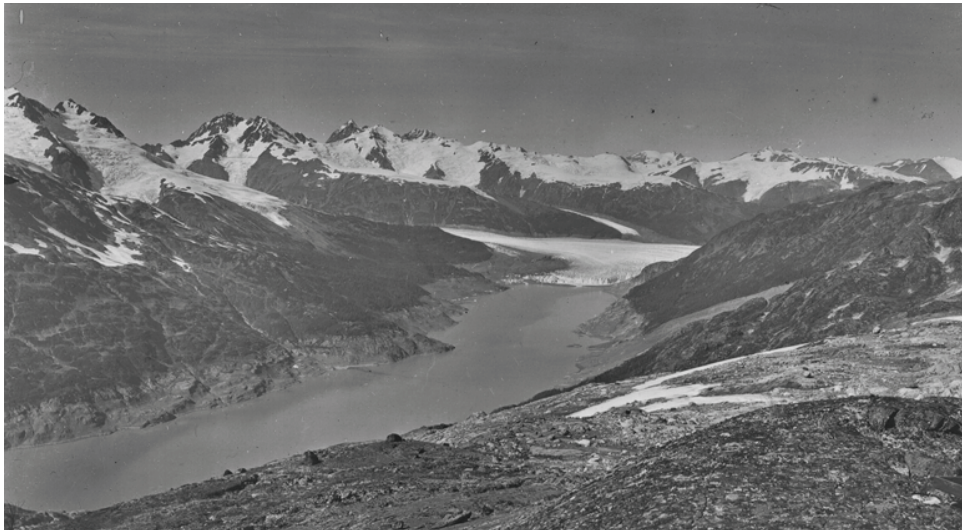
*Figure 2. Tide Lake, a glacier- and moraine-dammed lake in the northern Coast Mountains of British Columbia. The lake was dammed when Frank Mackie Glacier advanced across Bowser River and blocked its flow sometime in the 18<sup>th</sup> or 19<sup>th</sup> century. This photograph was taken in 1905, when the lake was dammed by a moraine that the glacier had built at its terminus. The lake drained catastrophically through the moraine about 1930. (Canada Department of Energy, Mines and Resources, National Air Photo Library, photograph IBC665.)*

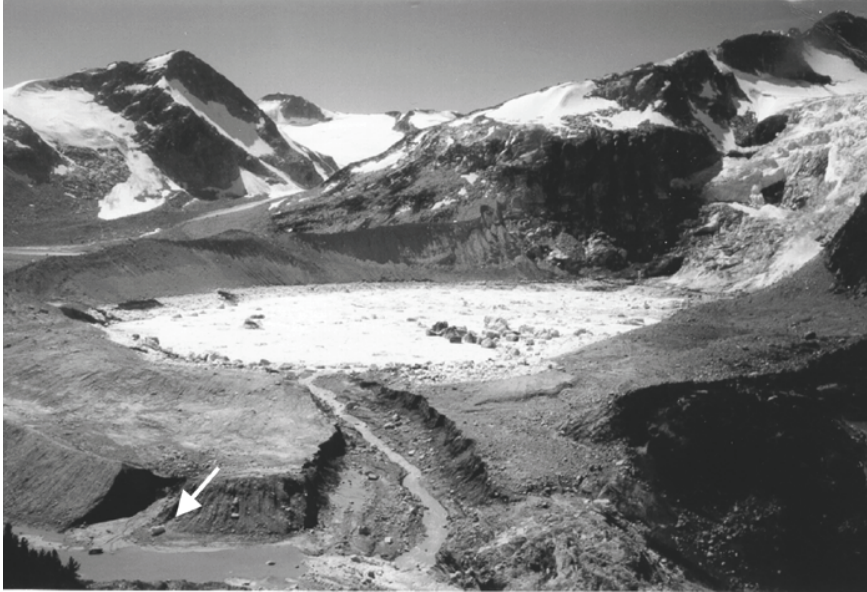
*Figure 3. Queen Bess Lake in the British Columbia Coast Mountains. This photograph was several years after 6 million m<sup>3</sup> of water flowed out of the lake in 1997. During unusually warm weather in July, 2-3 million m<sup>3</sup> of ice collapsed from the toe of Diadem Glacier (arrow) and plunged into the lake, producing a displacement wave that overtopped and incised the moraine (note moraine breach at 'o'). The upper limit of the displacement wave on the proximal flank of the moraine is delineated by the change in tone from white to pale gray.*

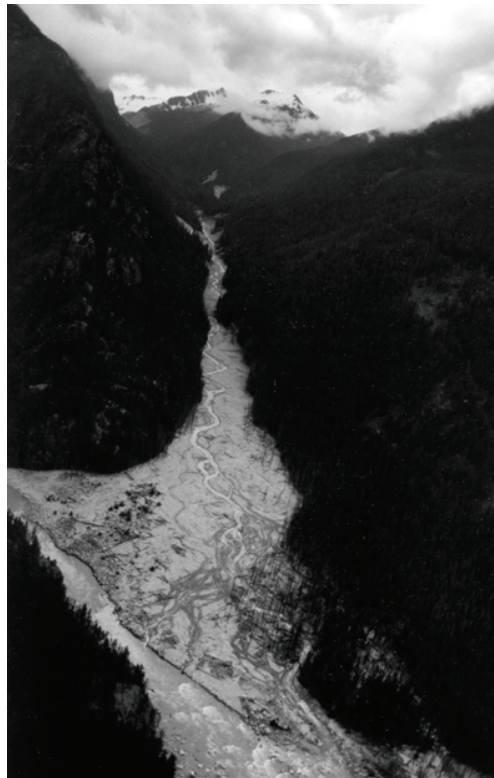
*Figure 4. Path of a large debris flow triggered by the sudden emptying of moraine-dammed Klattasine Lake in the southern Coast Mountains of British Columbia in the early 1970s. The escaping lake waters entrained several million cubic metres of sediment along its 8-km path.*

Outburst floods can erode, transport, and deposit huge amounts of sediment over distances of tens of kilometers (Figure 4). They broaden floodplains and destroy pre-flood channels. The changes can persist for decades, although rivers commonly quickly reestablish their pre-flood grades by incising the flood deposits.
