Hydrogeological Assessment for the Use of Groundwater in the Subcatchment Lauricocha, Huanuco, Peru

José Moreno, Flu Peña, Wai Ng, Pedro Navarro and Sheyla Palomino

Department of Environmental Geology and Geological risks, Geological, Mining and Metallurgical Institute, Peru

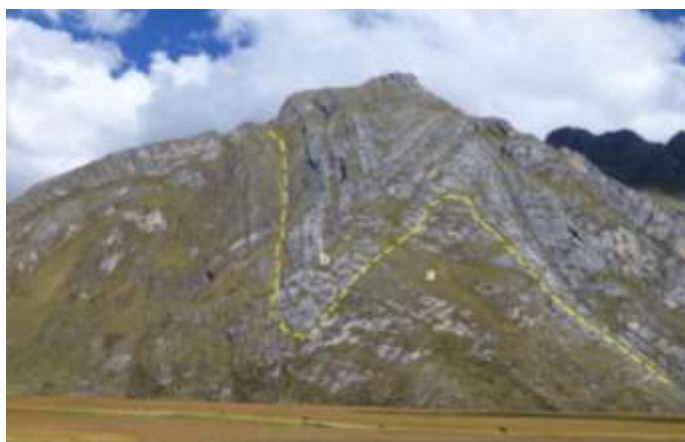
Figure 2 Outcrop of carbonated layered folds of those members 3 (a) and 4 (b) Jumasha geological formation, located in the southeast of the Añaspampa Lake.

Considering the geological mapping at 1:25 000 scale, where it is zoned the main types of rocks, soils and structures (faults, fractures and joints that influences the groundwater percolation), giving importance to lithology (Figure 02). The hydrogeological mapping, characterized each geological formation, differentiating their permeable and impermeable properties and zoning rocks reservoirs with their capacity to store and transmit groundwater, called aquifers. In the field trip was developed seven specific Lefrance permeability tests for fissured aquifers, these tests helped to obtain a hydrogeological correspondence through hydraulic conductivity (Custodio, 1983).

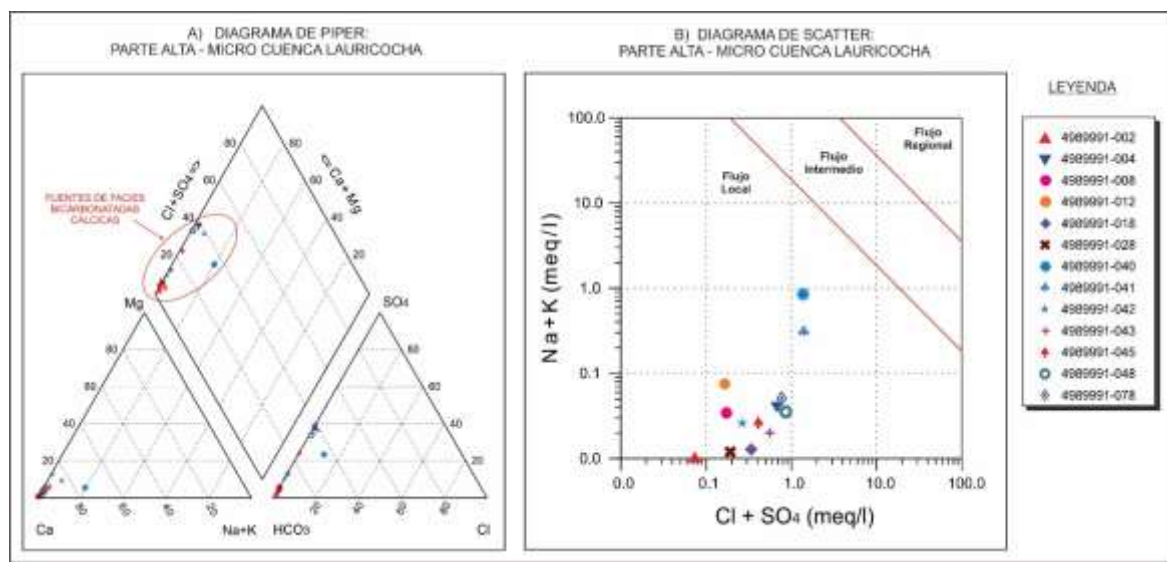
Figure 4: Scatter and Piper diagram for groundwater sources located on the top of the Lauricocha Subcatchment.

Figures 4, 5 and 6 showed diagrams of Piper and Scatter for 3 sample groups in the upper, middle and lower zone respectively. The graphs gathered the sampled sources, 11 in the top part (Figure 4), 14 in the middle part (Figure 5) and 12 in the lower part (Figure 6) of the subcatchment.

Piper diagrams showed that water sources are within the calcium bicarbonate facies; further Scatter diagrams showed that the waters belong to a local stream, considered young short path water, with a transient contact time with the soil and rocks of the study area.

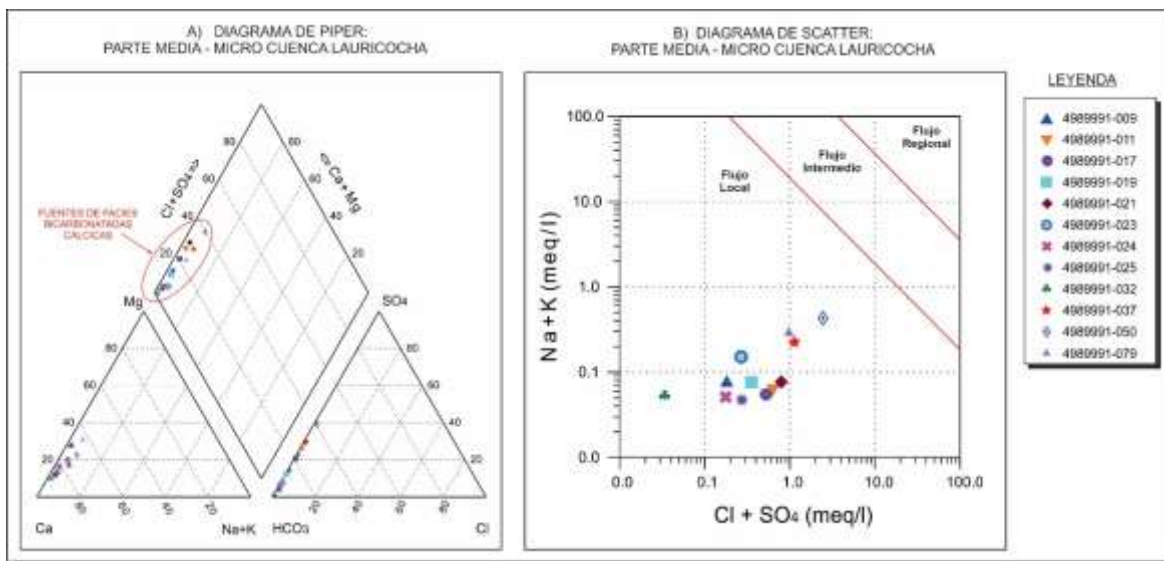
Figure 5: Piper and Scatter diagram for groundwater sources located in the middle of the Lauricocha Subcatchment.

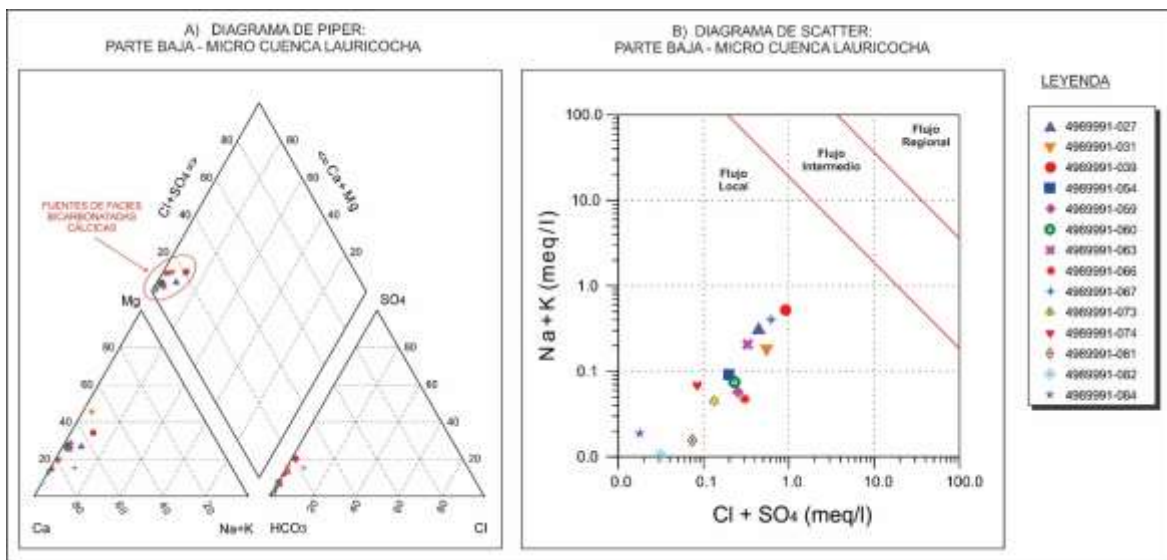
Figure 6: Piper and Scatter diagram for groundwater sources located in the lower part of the Lauricocha Sub catchment.

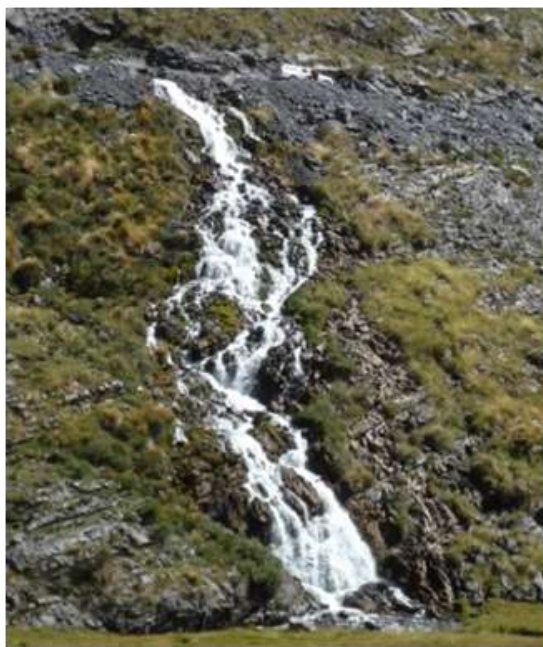
Figure 9 Shuplamachay one spring with 80 l / s flow, considered as the most important for their use and recruitment

One of the selected sources is the Shuplamachay 1, 4989991-067, considered as the most important because of its constant flow throughout the year, approximately 80 L/seg.
